Work Scope

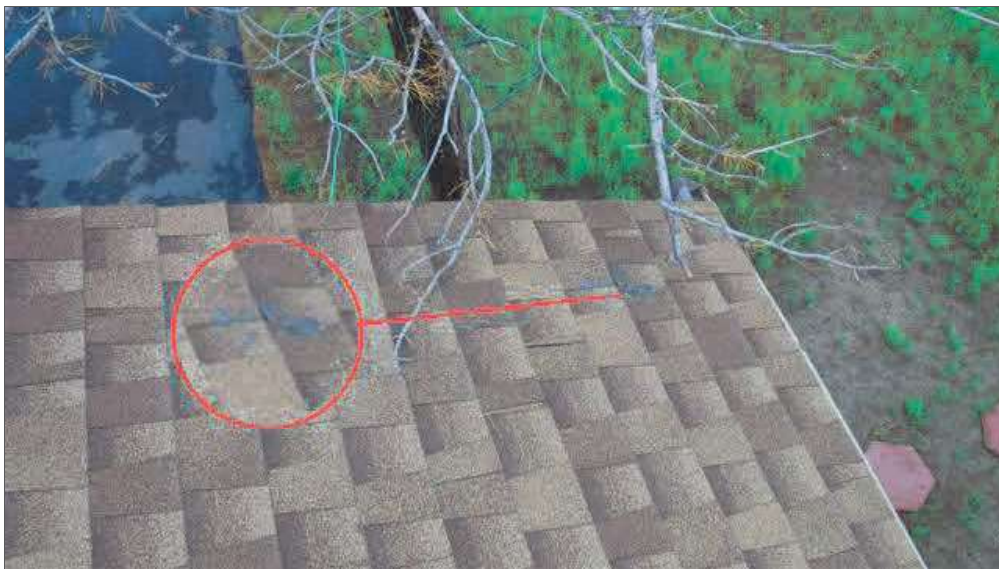
1.0 (2) Tree limbs should be kept from touching the roof surface. They can cause premature failure of the shingles. There's some very minor damage to the roof from a limb rubbing on it. The rest of the roof is in great shape.

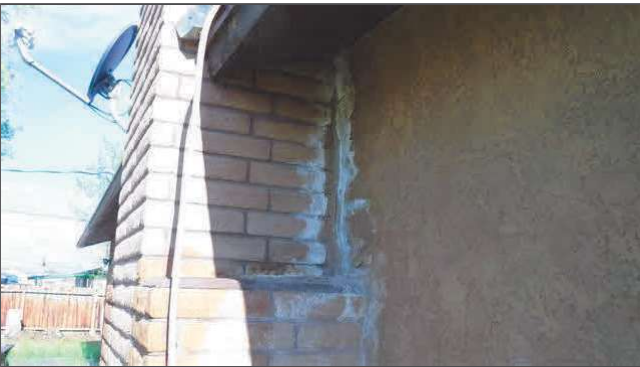
1.3 The roof drainage system consisted of conventional gutters hung from the roof edges feeding downspouts at least in some areas. The gutter out front doesn't have a downspout and the one out back doesn't either.

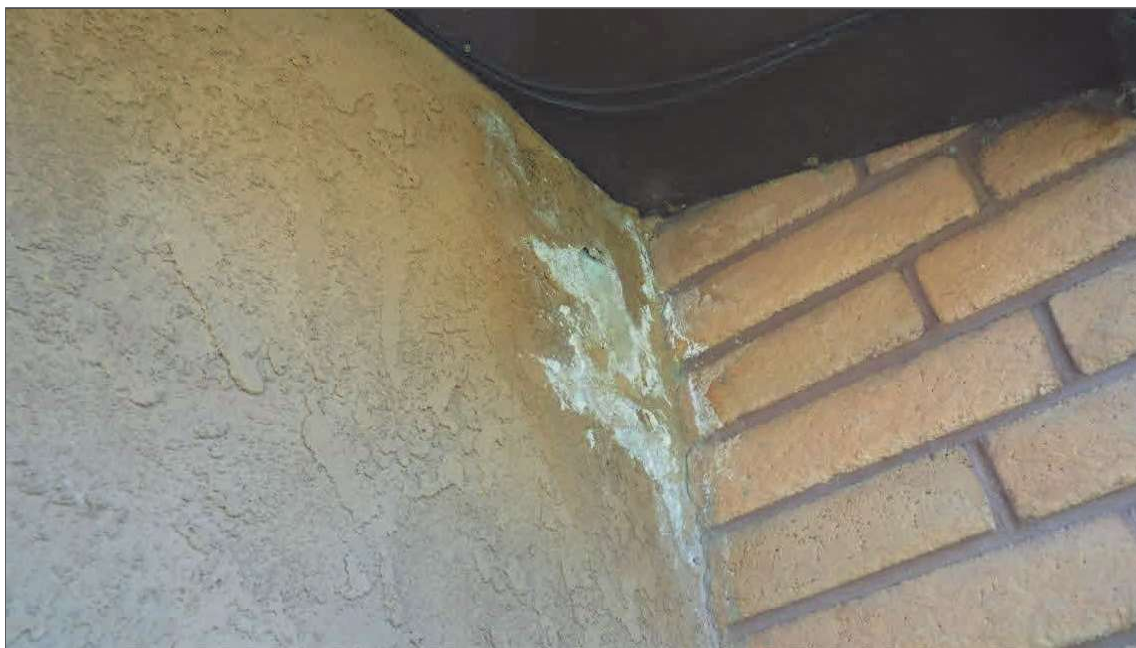
1.4 (1) The cooler on the roof has been leaking from some time in the past and the hard water stains are visible on the chimney.

1.4 (2) The mortar cap on the chimney has some cracks that should be sealed.

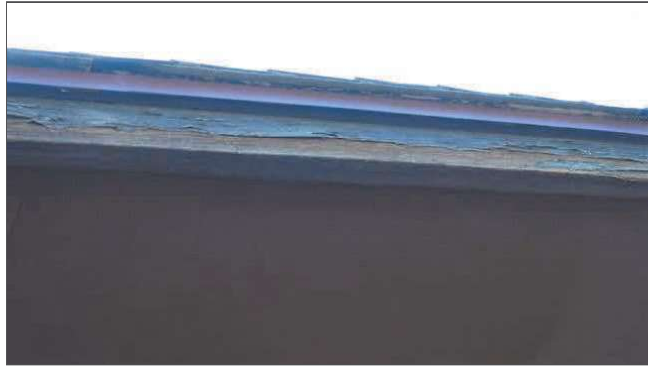
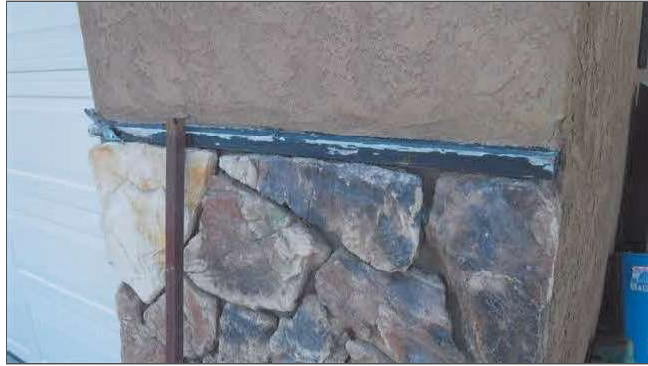
Some of the trim and fascia boards on the home exhibited moderate weathering and deterioration commensurate with its age.

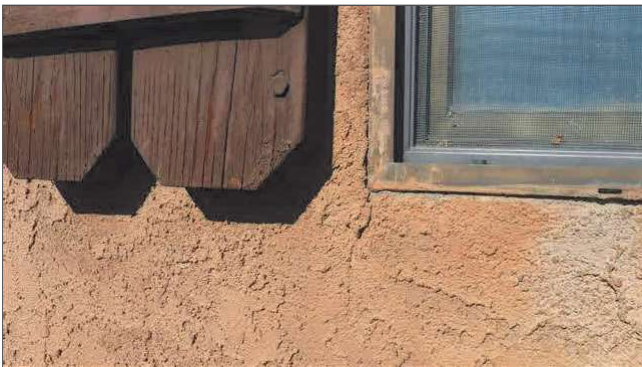
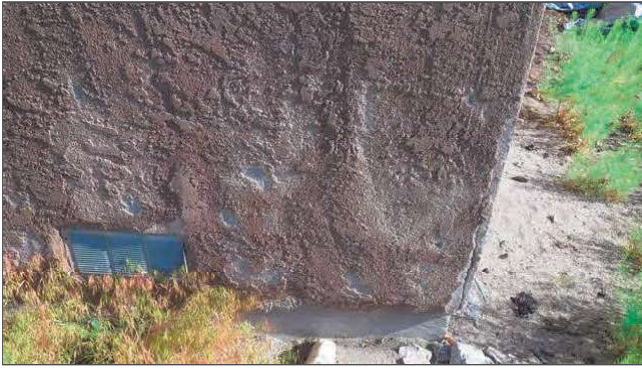
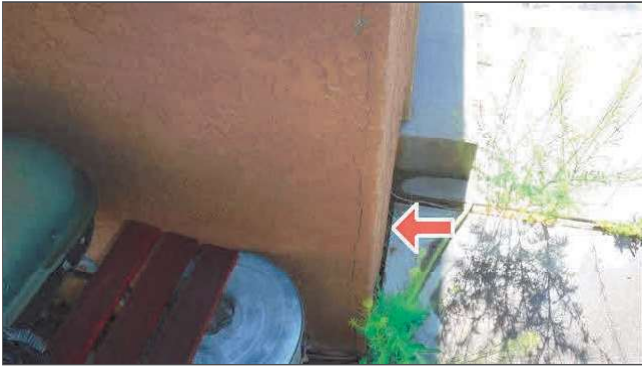
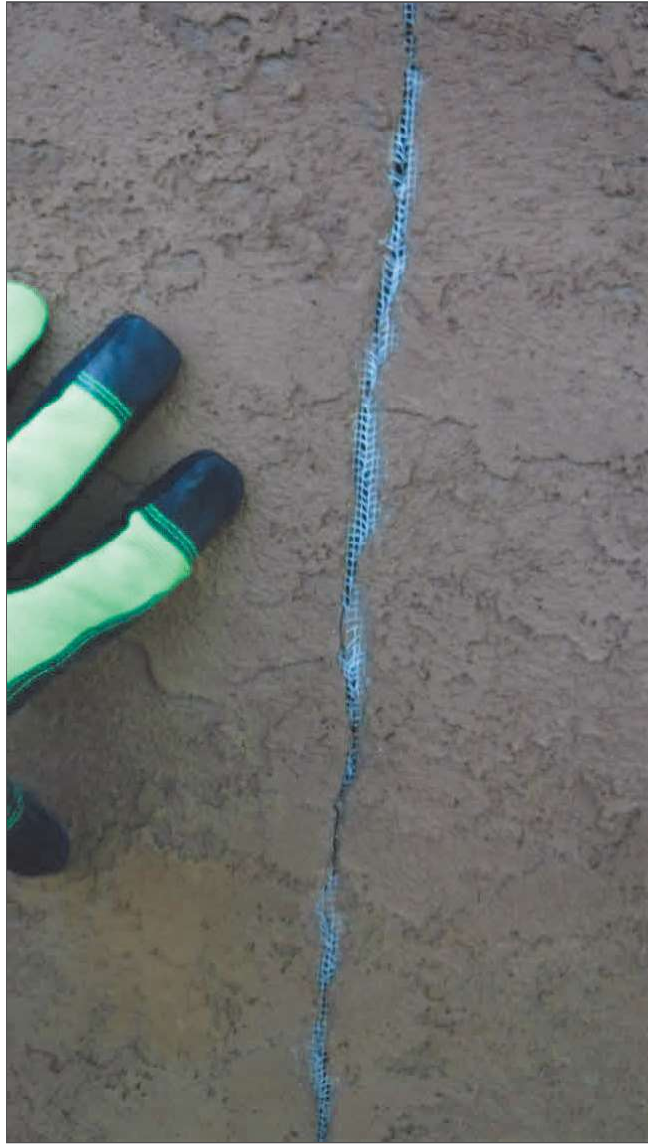
2.0 (1) The wall cladding, flashing and trim were inspected.

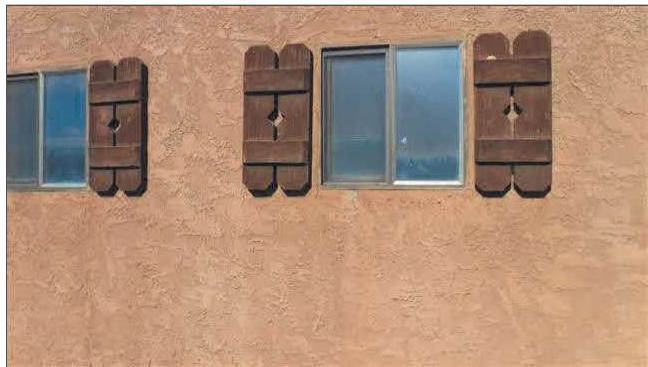
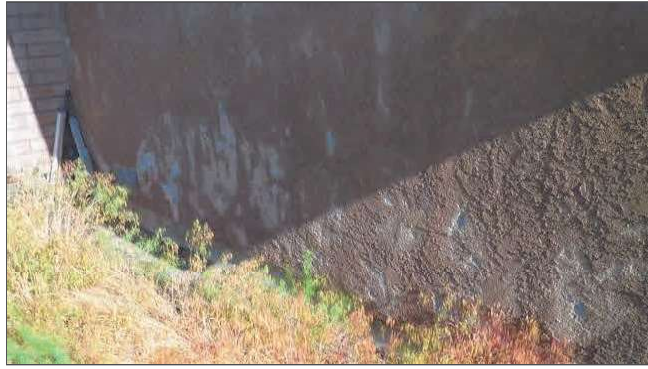
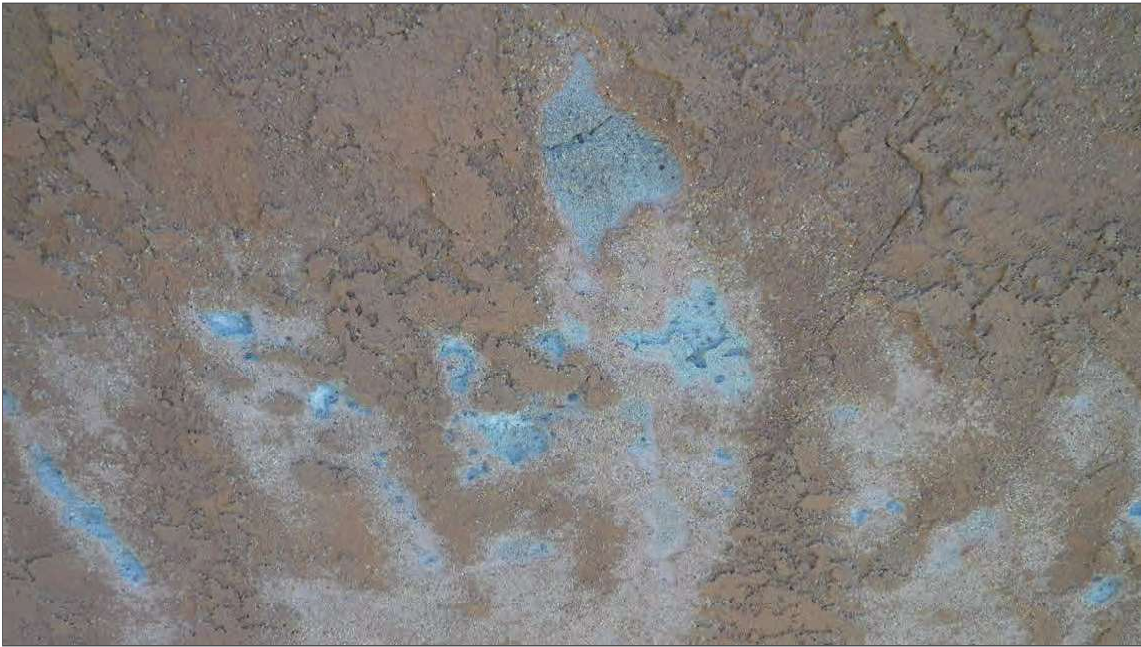
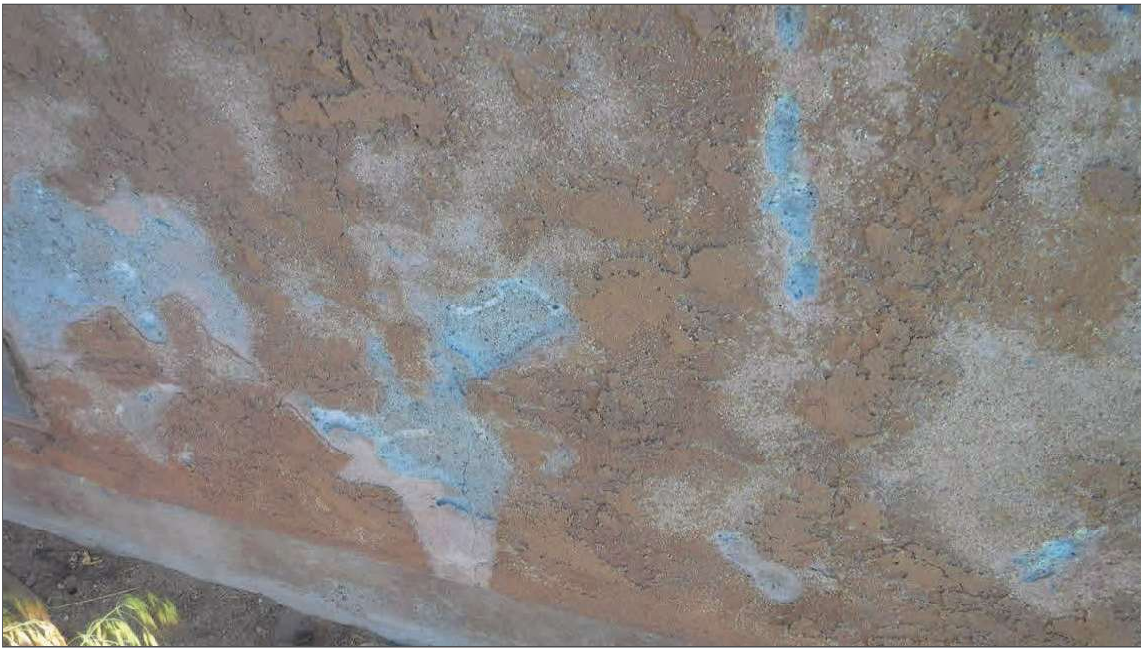
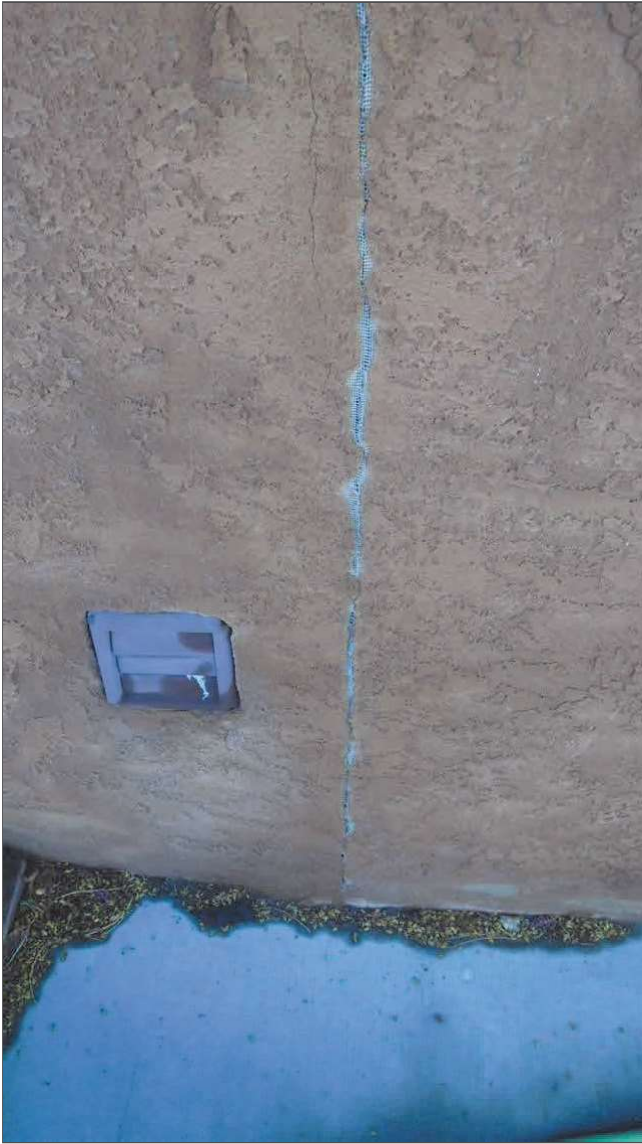
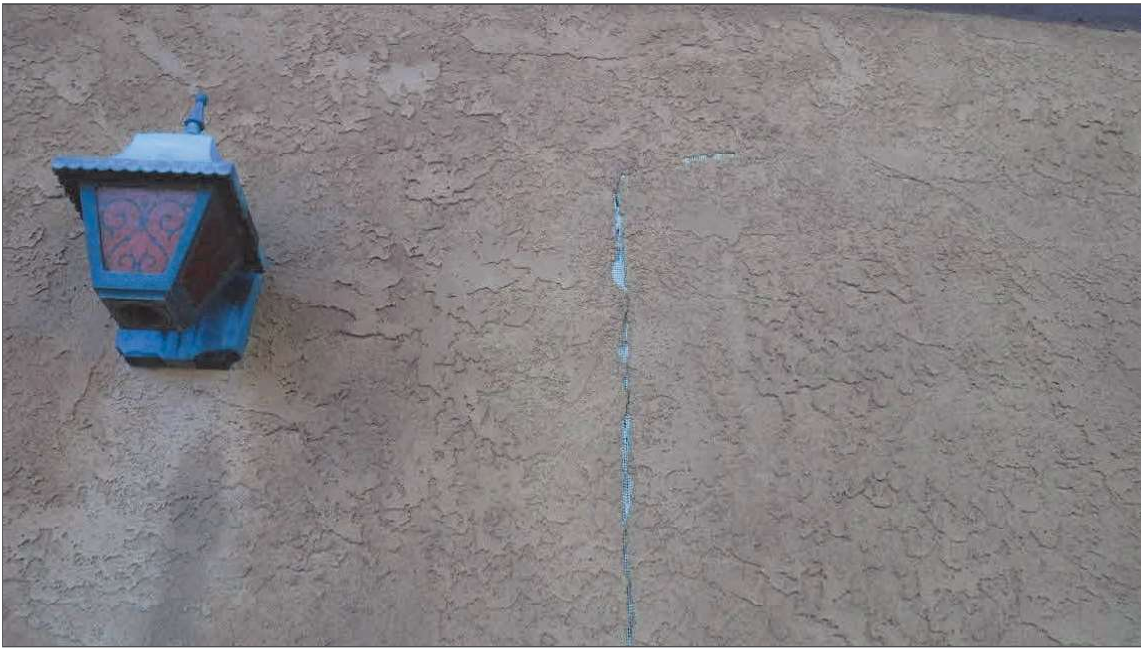
2.0 (2) There are some cracks in the stucco. Stucco consists of Portland cement, sand, lime and water, stucco is a long-lasting, low-maintenance siding option. But just like any other construction material that includes Portland cement, stucco is prone to cracking.

Though cracks in stucco can occur due to different factors, including wrong mix proportions, insufficient mixing, poor workmanship, seismic movement and seasonal changes, two leading causes of cracks in stucco are the house settling process and shrinkage-induced stresses, which typically occur during the drying period.

The Problems behind Stucco Cracking. Hairline cracks aren't as serious as deep cracks. However, they can provide a pathway for moisture and water to enter into a wall system. Once moisture or water gets inside a wall, it will inevitably cause further damage. Although cracks smaller than 1/16 inches usually don't undermine the integrity of exterior stucco, repairing them immediately will prevent them from escalating into something worse.

There are a few areas of the stucco that need some prep, prime and paint also.

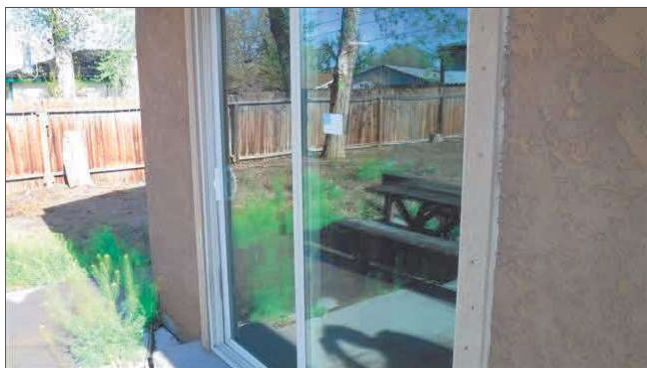
2.1 (1) Exterior doors were inspected. The sliding screen door is missing.

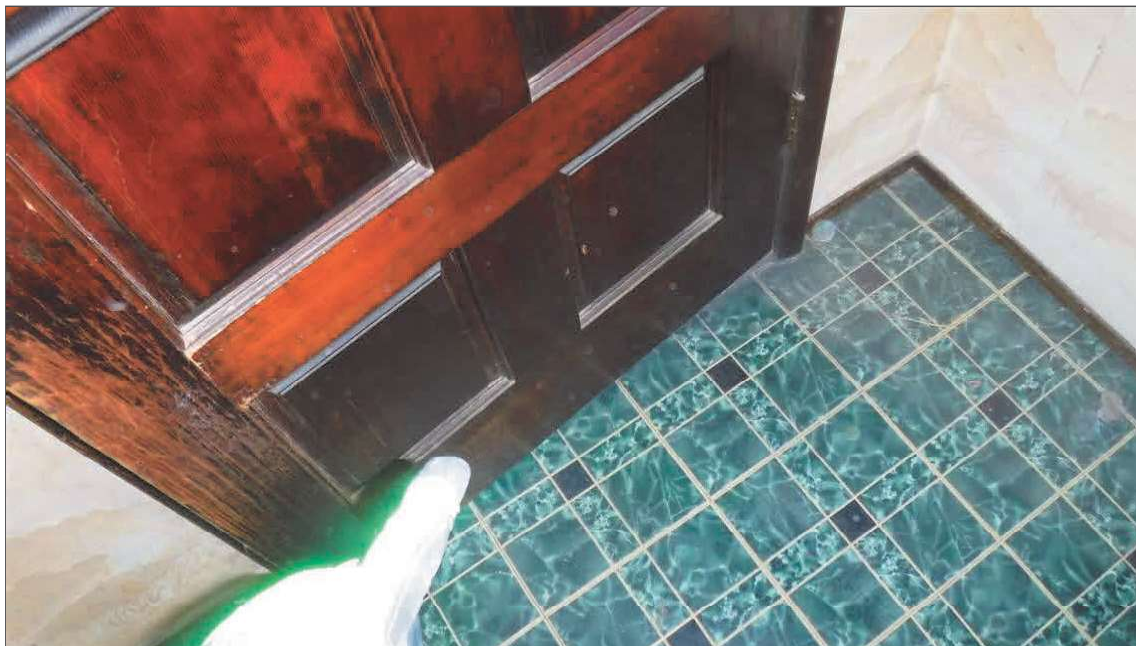
2.1 (2) The front door rubs on the bottom.

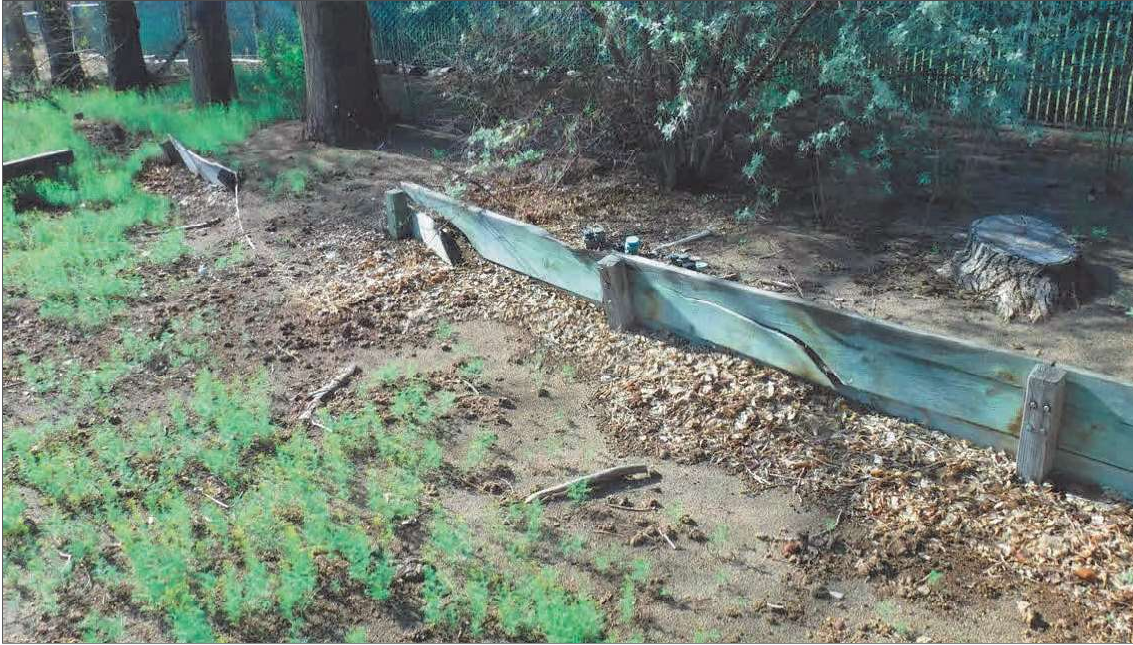
2.3 (1) The home site was fairly level. We recommend a downward slope of 6 inches within 10 feet of the home to make sure there is adequate runoff of water away from the home.

The retaining wall out back is damaged.

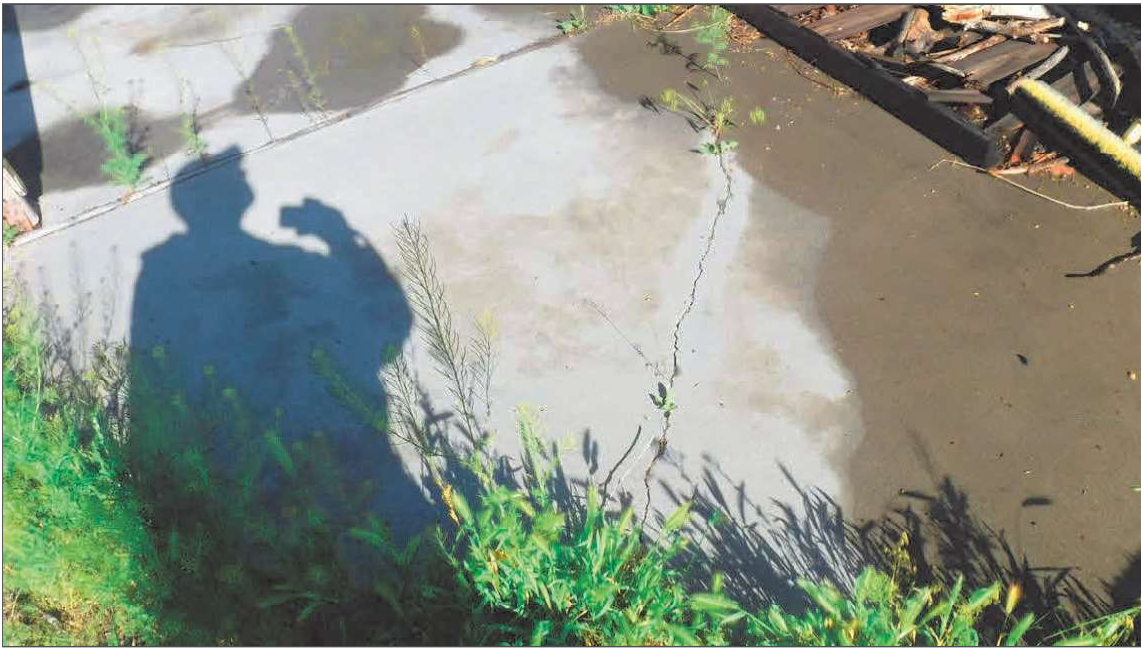
2.3 (2) Common cracks were visible in the concrete around the home. Cracks exceeding ¼ inch should be filled with an appropriate sealant to avoid continued damage from freezing moisture.

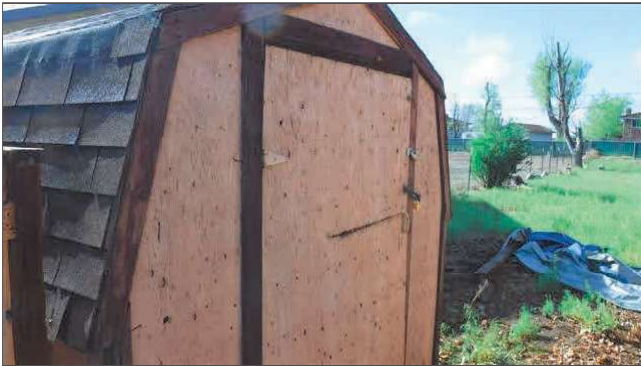
2.5 The inspection of fences and gates is not provided for in the Nevada statutes governing home inspections, we may identify items that we find that need repair with these during the course of our home inspection.

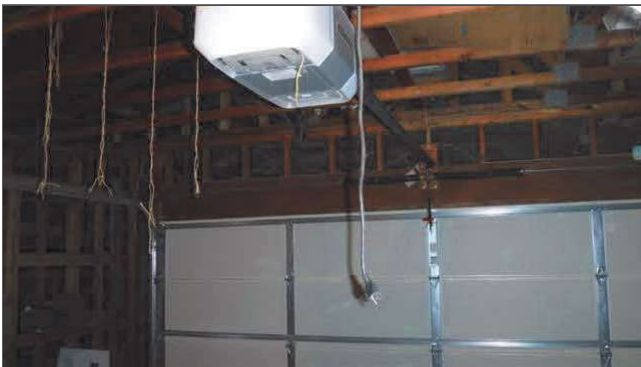
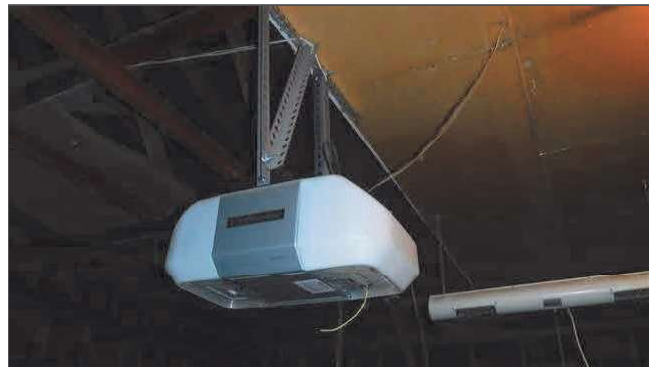
3.5 The automatic opener was unplugged at the time of the inspection. Plugging in disconnected appliances exceeds the scope of the General Home Inspection. You should ask the seller about the operation of any unplugged openers before attempting to operate them.

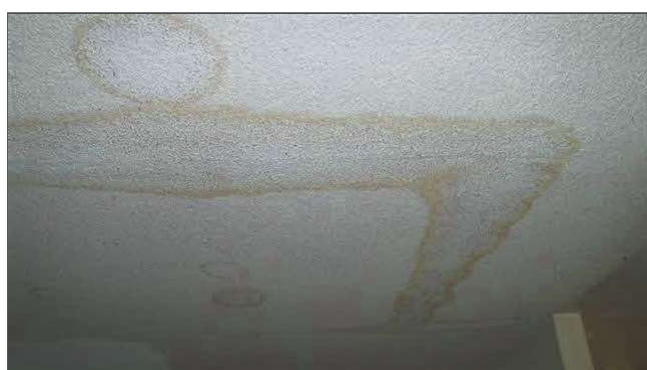
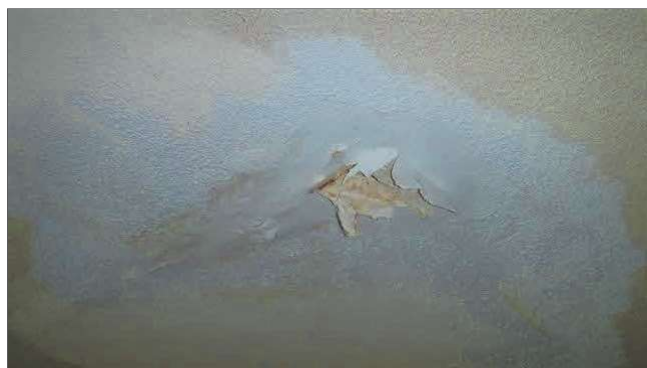
4.0 (1) The ceilings of the home were inspected. The ceiling needs some repairs. The roof is in great shape, the evaporative cooler has leaked down into the attic and the water has gotten to the ceiling in this room.

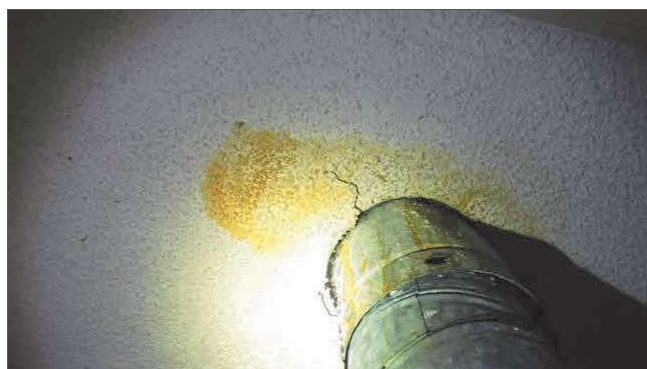
4.0 (2) There are some old water stains around the flue pipe for the furnace at the ceiling.

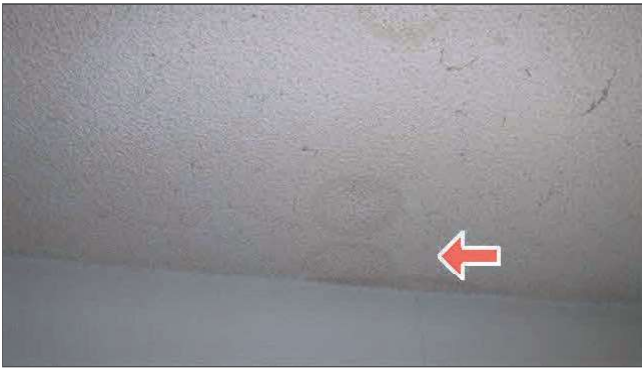
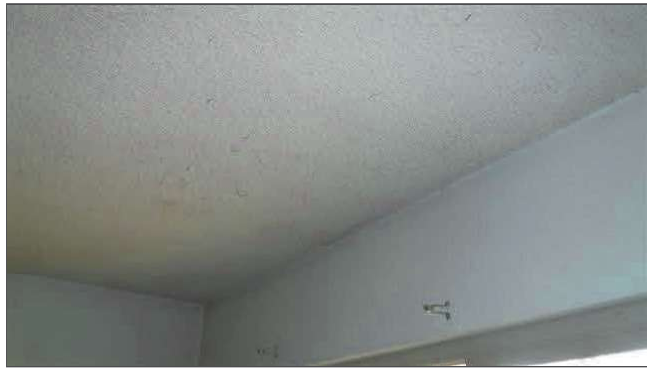
4.0 (3) There's an old water stain on one of the bedroom ceilings.

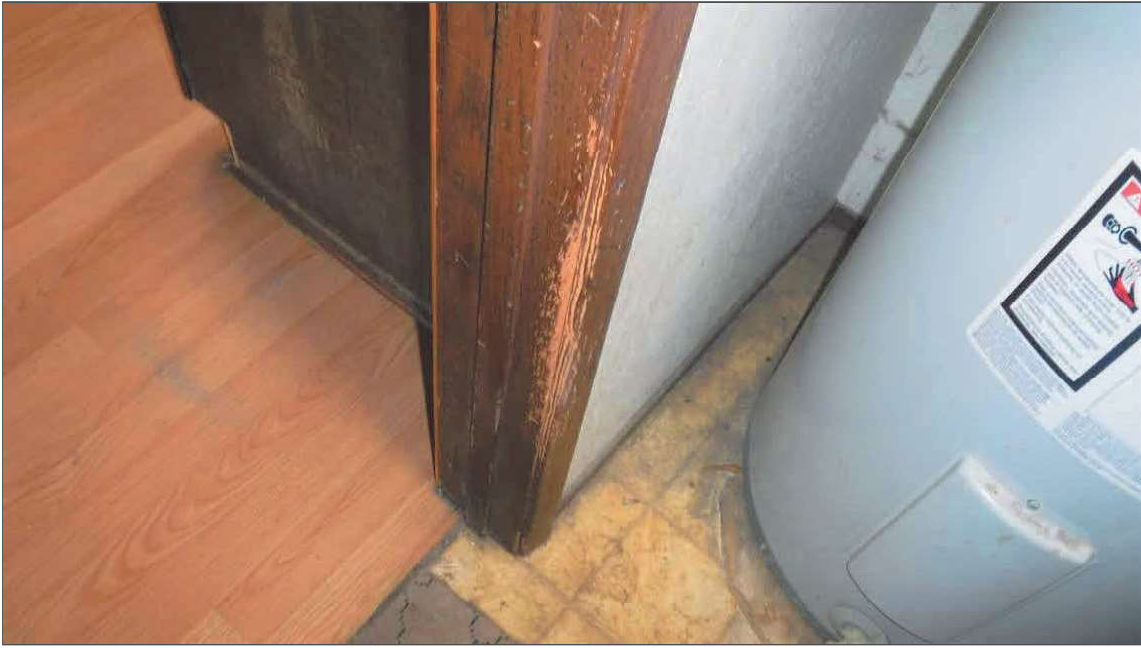
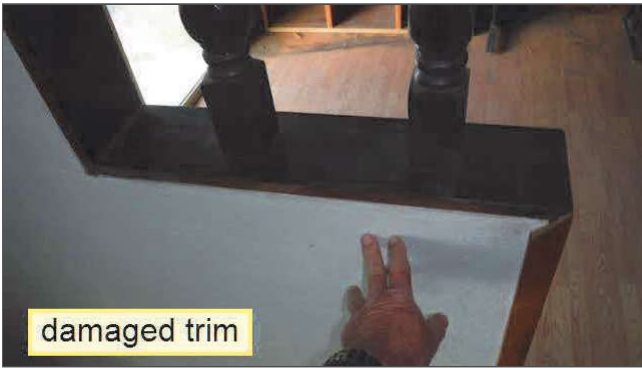
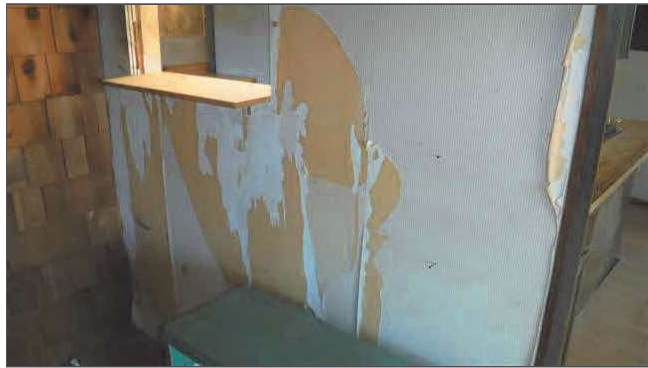
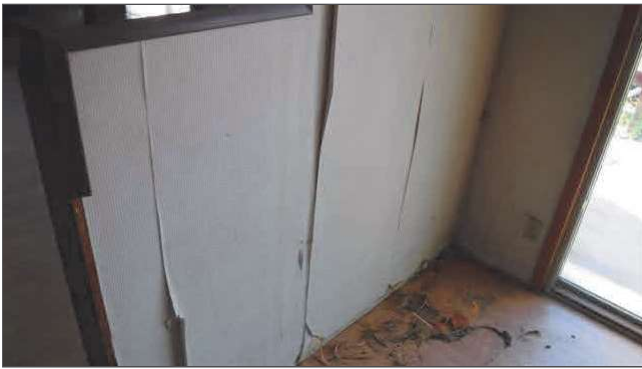
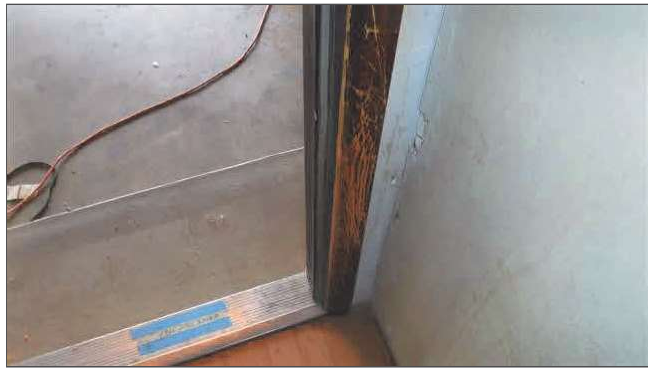
4.1 (1) The walls of the home were inspected.

The inspector was unable to confirm the presence of insulation in the walls.

Interior walls could use some prep, prime and paint in places.

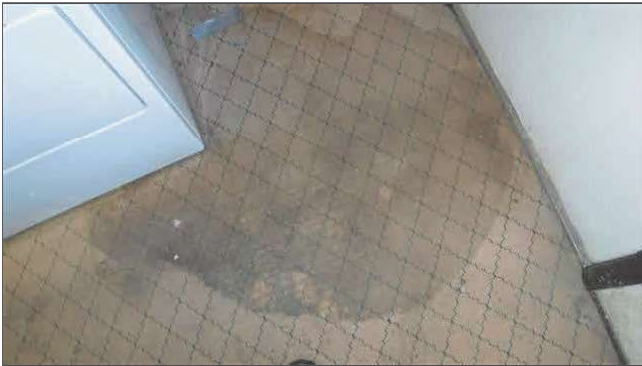
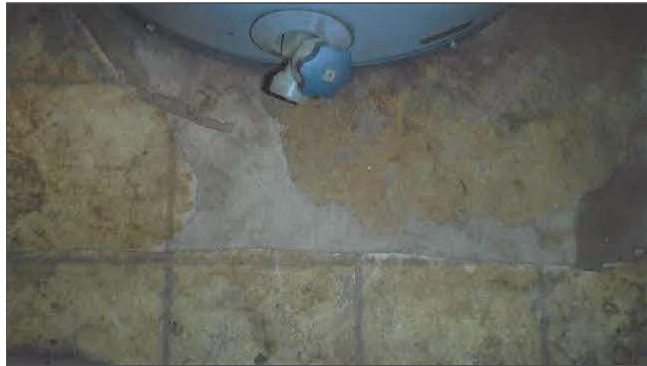
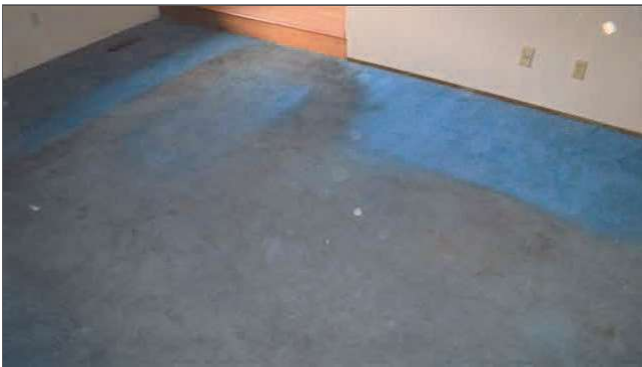
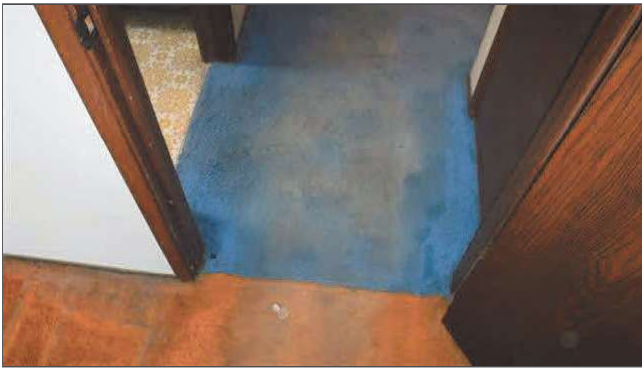
4.2 (1) The floors of the home were inspected. Flooring under the water heater (just the sheet vinyl) is damaged, and carpet is stained in the home also.

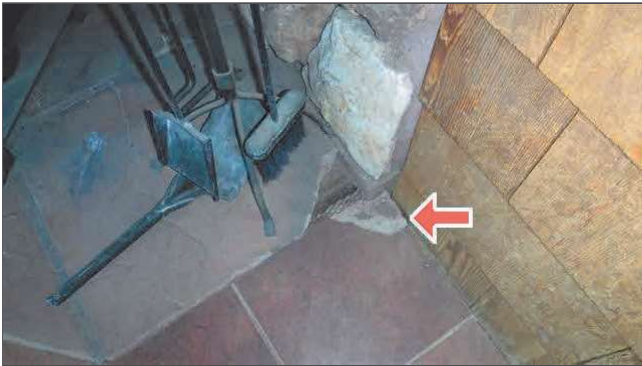
4.2 (2) Damaged tile to the right of the wood stove.

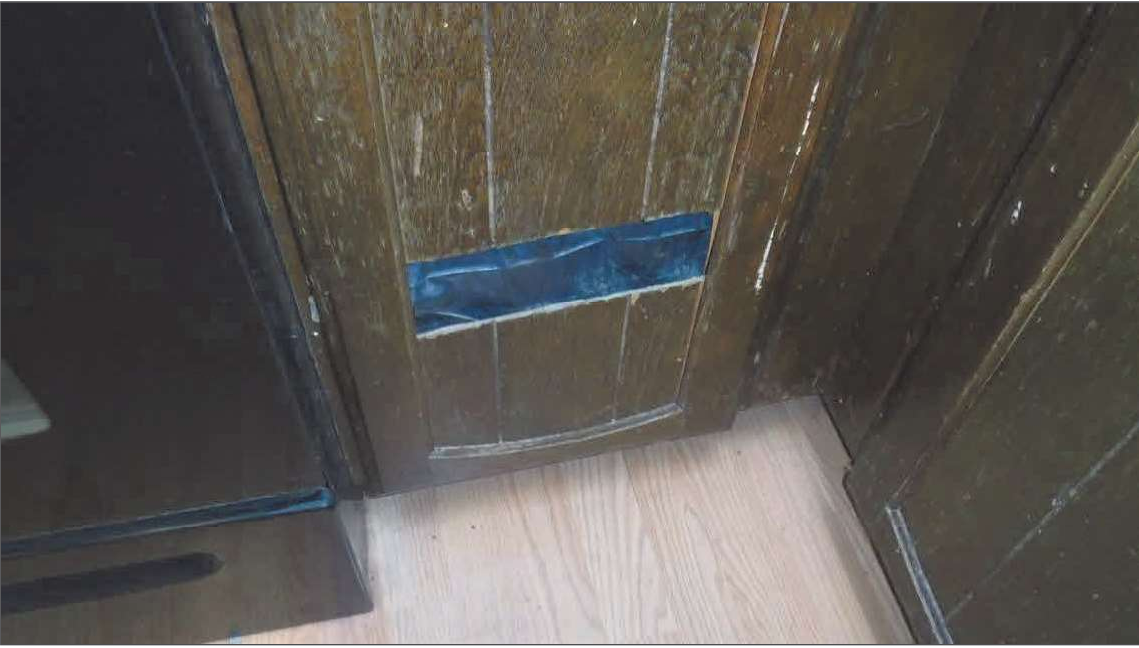
4.3 (1) The cabinetry and countertops of the home were inspected. There's a damaged kitchen cabinet door.

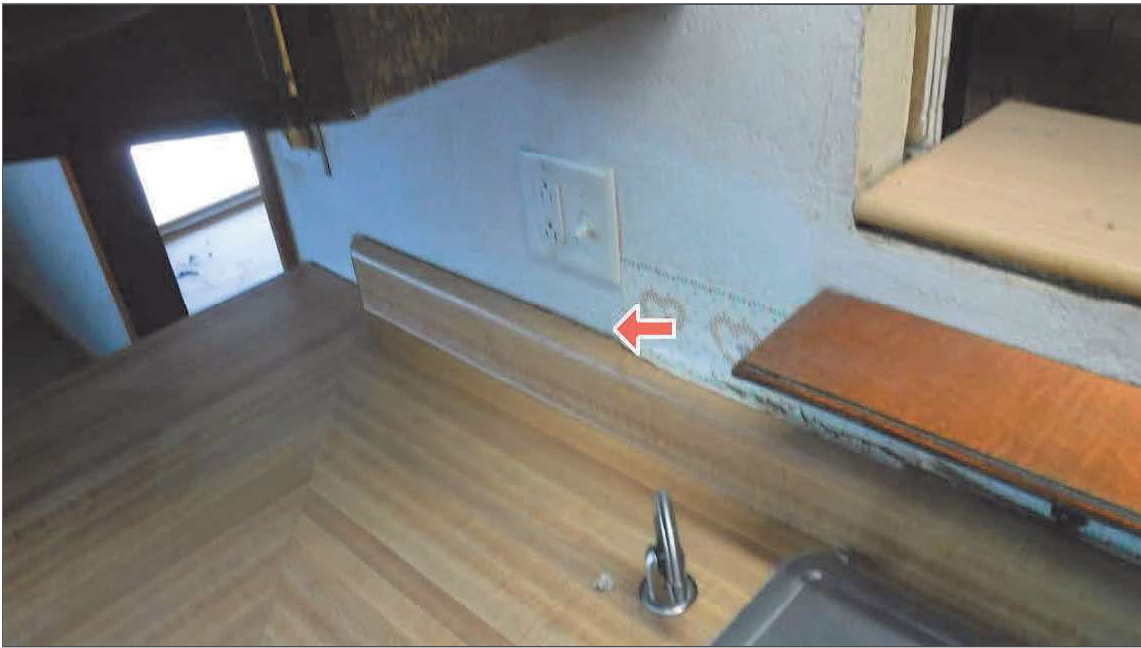
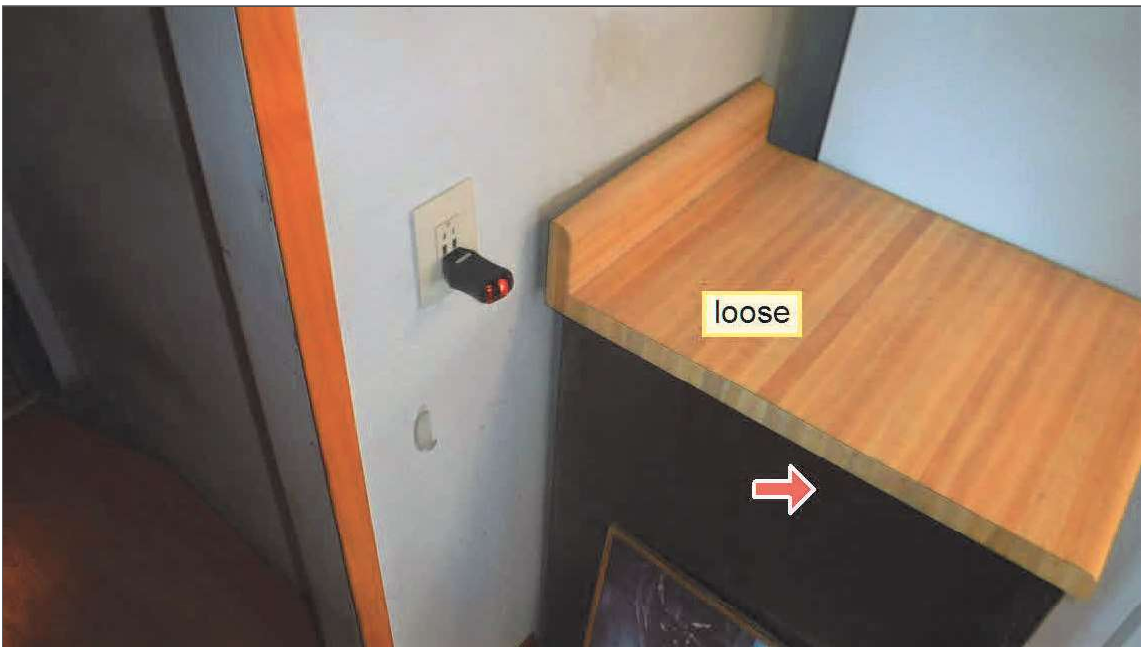
4.3 (2) The countertop could use some finishing work where it meets the wall (backsplash) and one small section of counter is very loose.

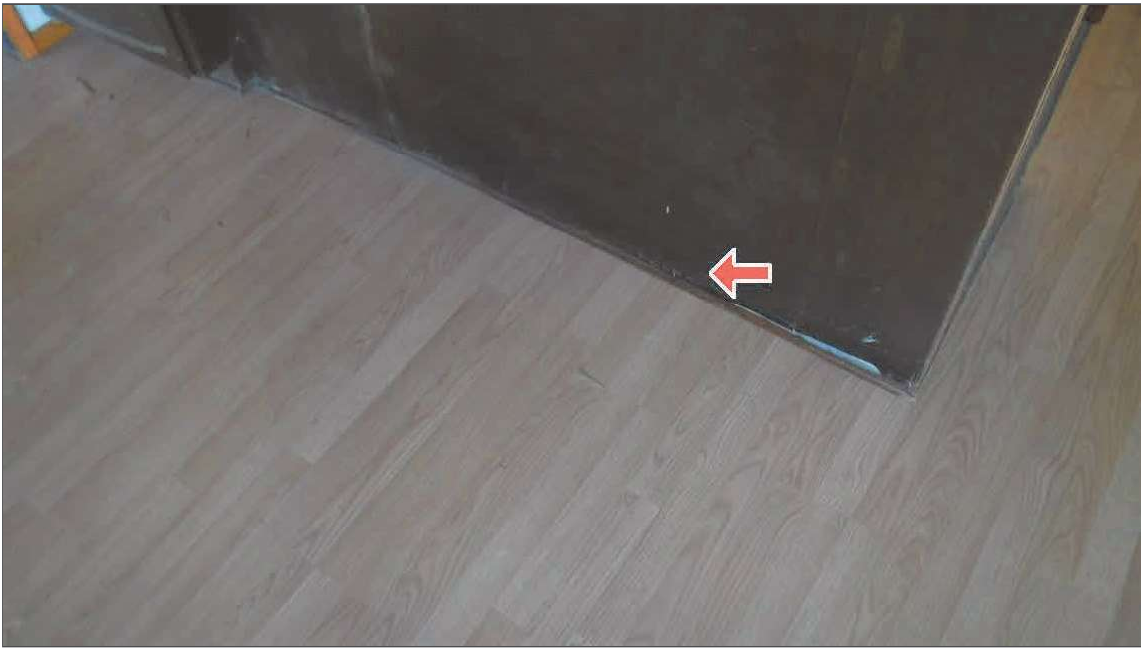
4.3 (3) Trim is damaged on this cabinet.

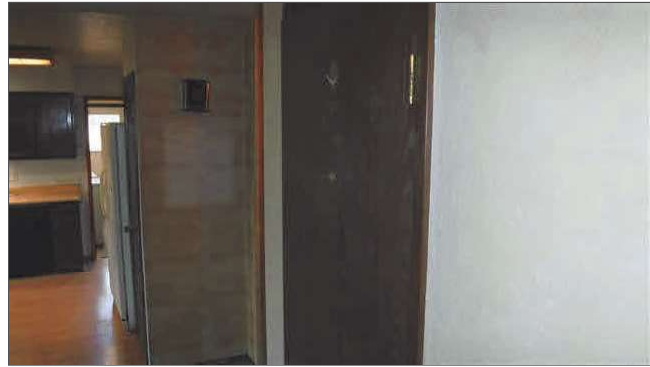
4.4 (1) The doors of the home were inspected. Damaged bedroom door here.

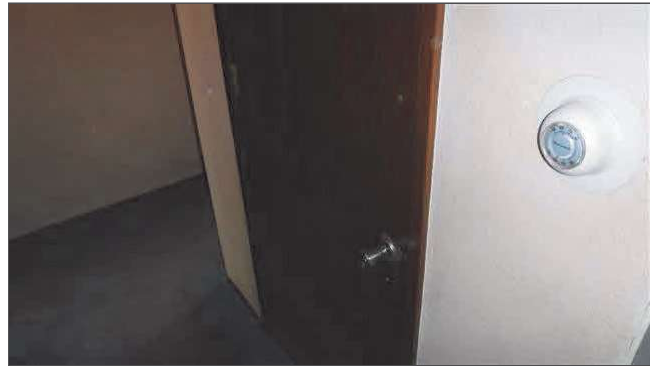
4.4 (2) This door does not latch when closed.

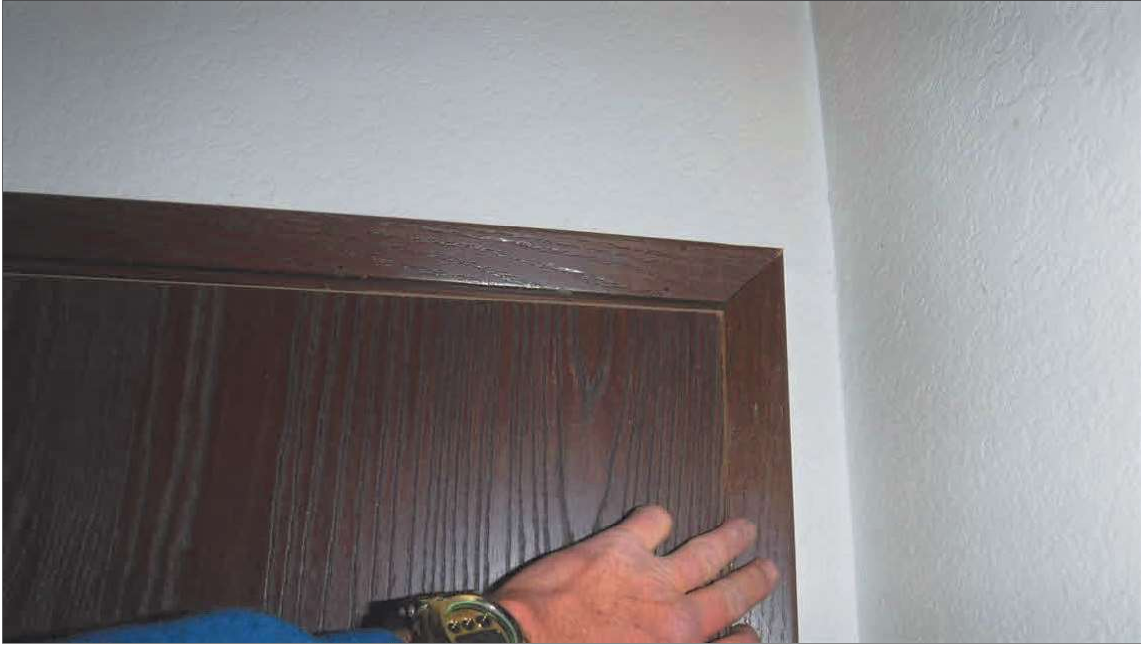
4.4 (3) This interior door rubs when opening and closing it.

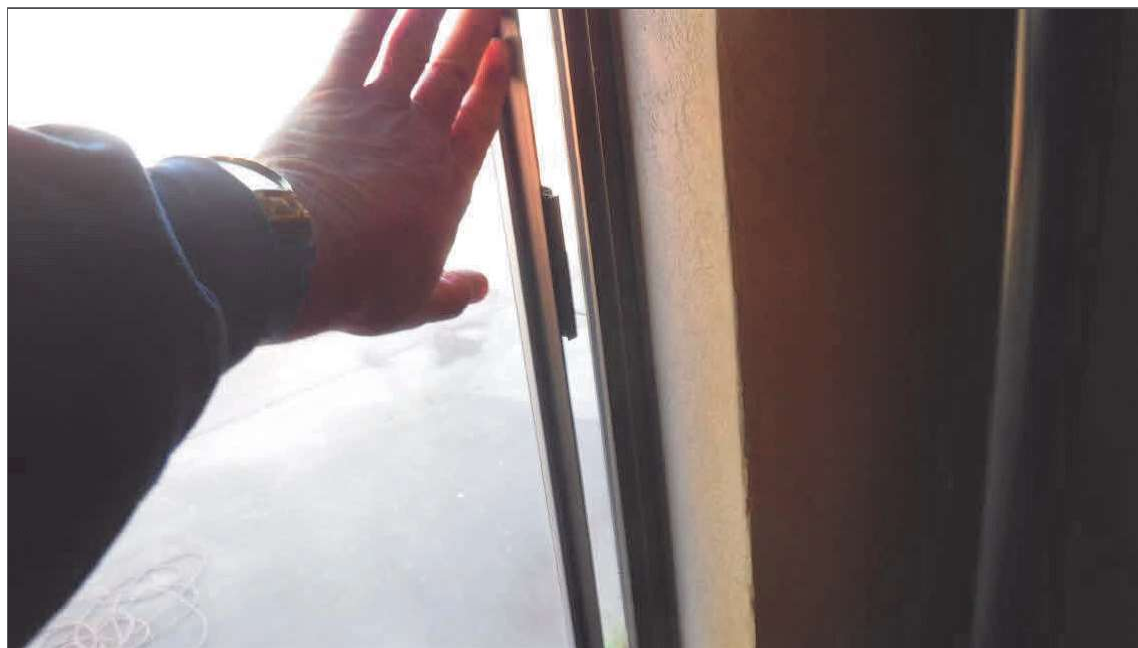
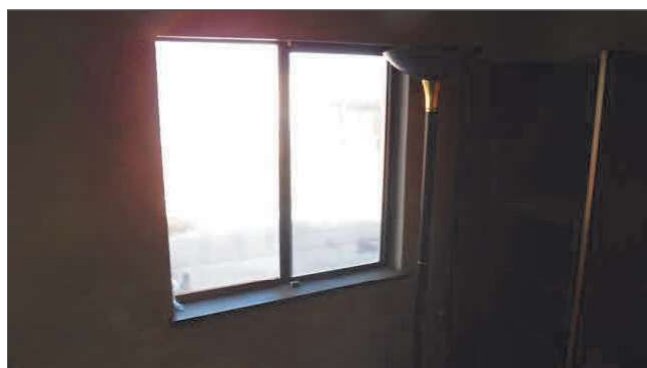
4.5 (2) This window didn't latch when closed.

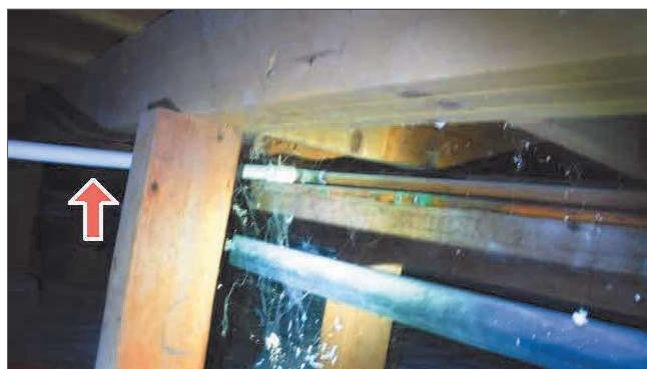
5.1 The Inspector examined the crawlspace from the inside the crawlspace. There is white PVC plumbing under the home that is being used for the supply system.

In most cases (although we don't inspect to code) PVC piping shall be installed only outside the foundation of any building or structure or parts thereof. It shall be buried for its entire length except vertical piping may be extended above grade. shall not be installed within or under any building or structure or mobile home or commercial coach or parts thereof. The term "building or structure or parts thereof" shall include structures such as porches and steps, whether roofed or not, roofed porte-cocheres, roofed patios, carports, covered walks, covered driveways and similar structures or appurtenances. [UPC 604.1]

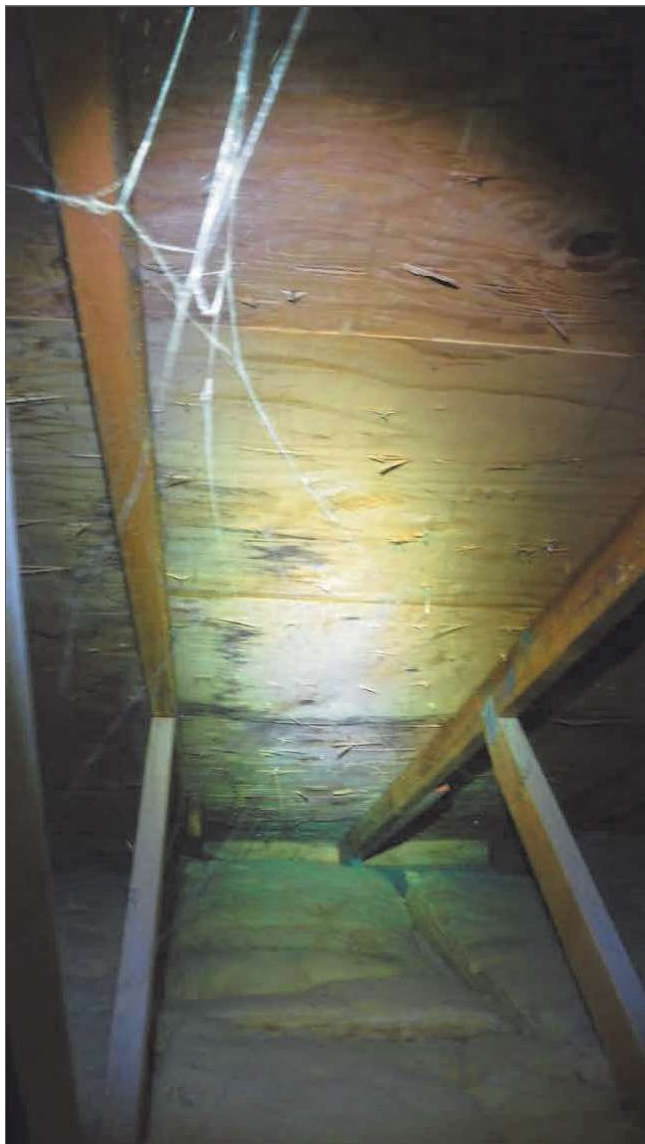
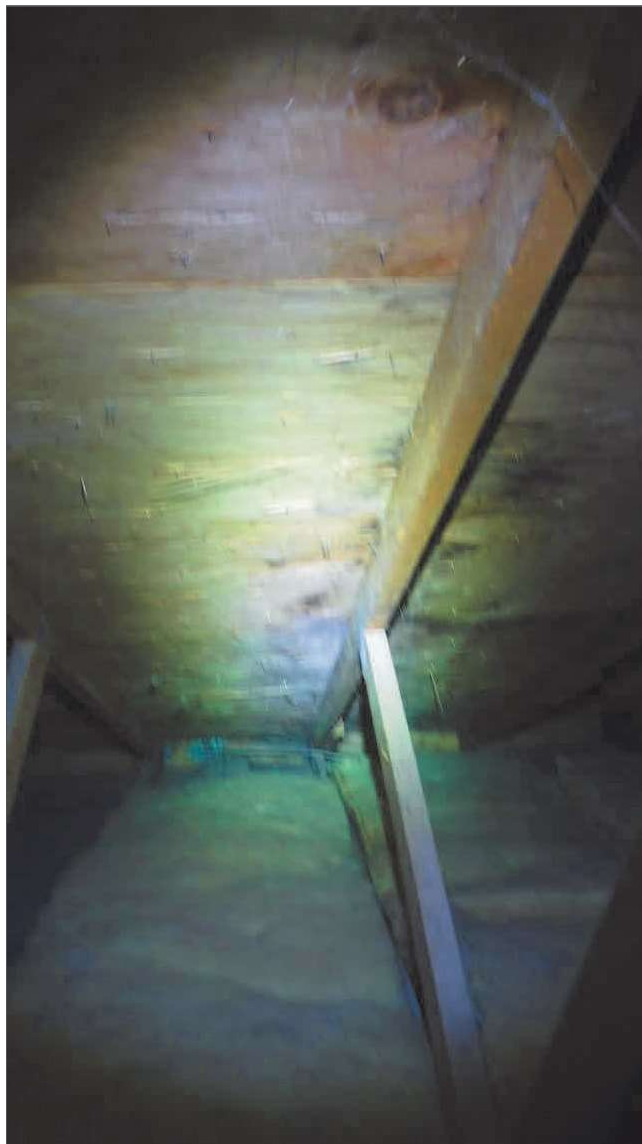
5.5 (1) The roof structure and attic was inspected. Other than what was noted in the evaporative cooler section. There are some old water stains of the roof decking in the attic.

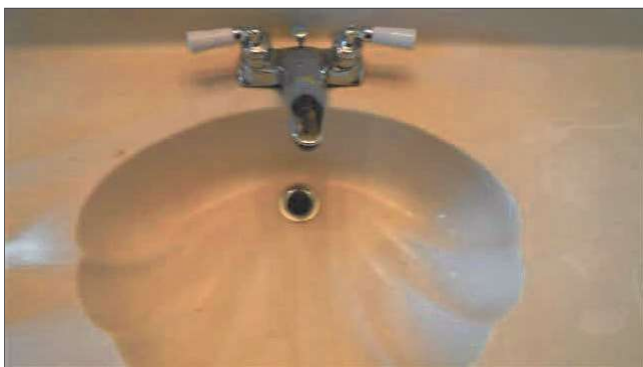
6.0 (1) The plumbing drain, waste and vents were inspected. The drain stopper is missing from this plumbing fixture
