Work Scope

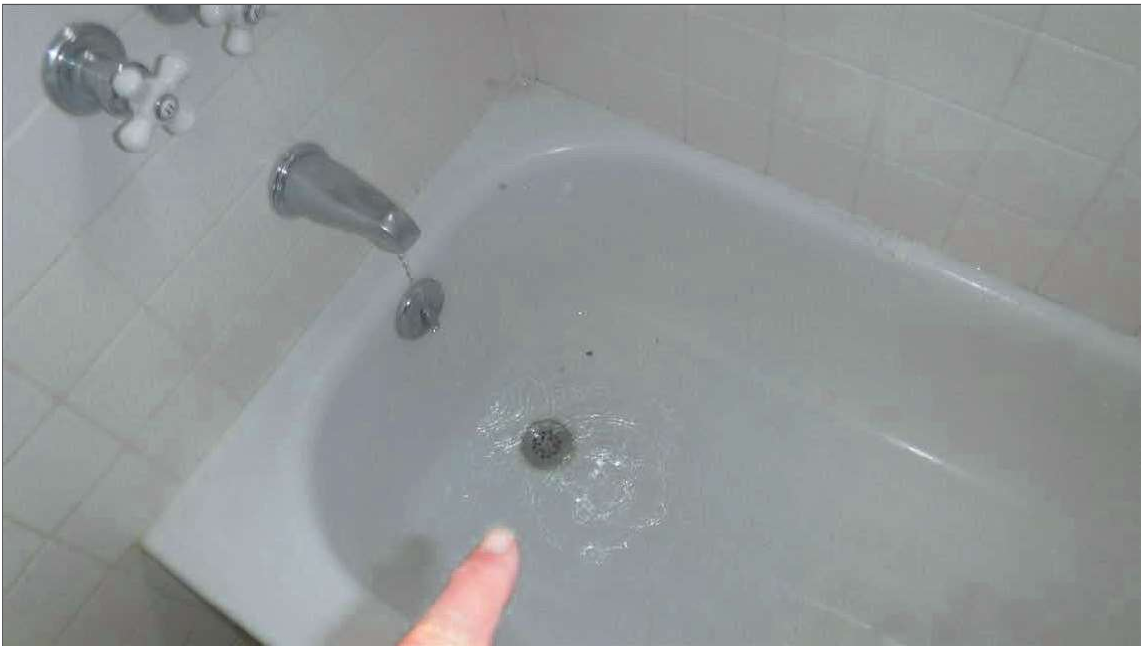
6.0 (2) This shower/tub had poor drainage at the time of the inspection. The Inspector recommends that an evaluation and any necessary work be performed by a qualified plumbing contractor.

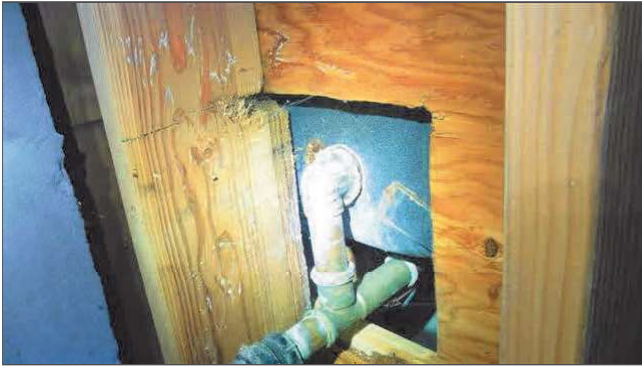
6.0 (3) There are two small drain leaks into the crawlspace. Looks like they are coming from the bathrooms.

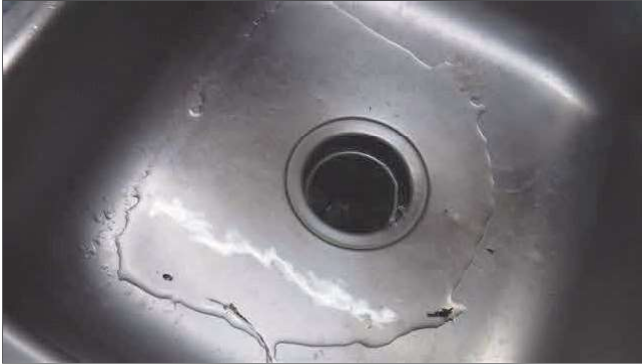
6.0 (4) This side of the kitchen sink backed up when the dishwasher was draining.

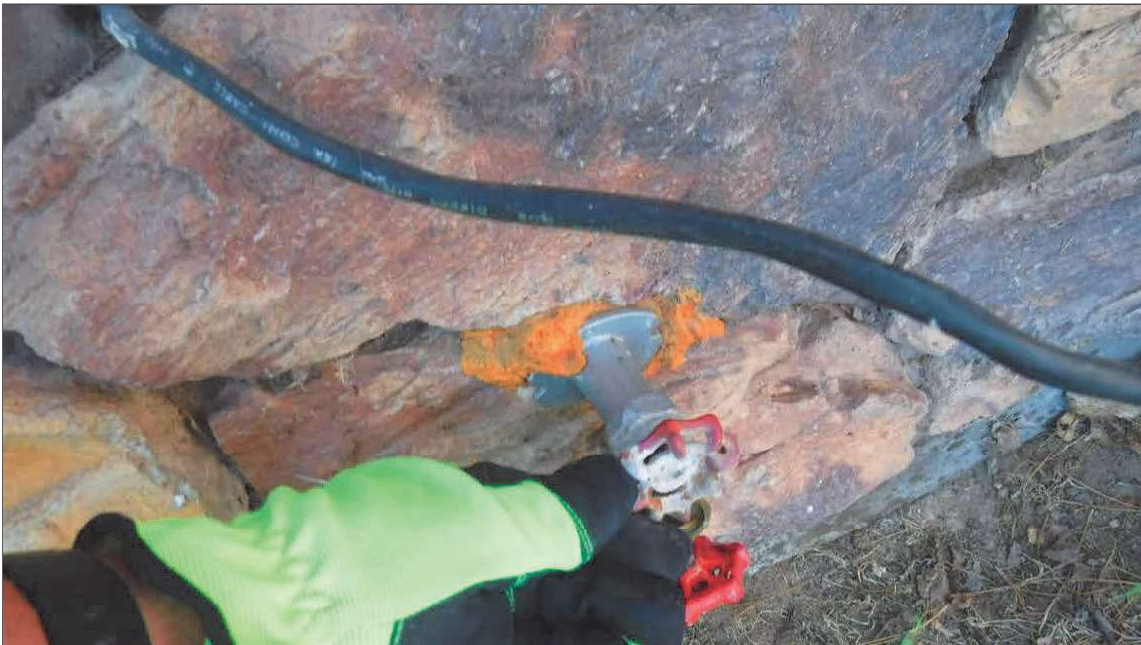
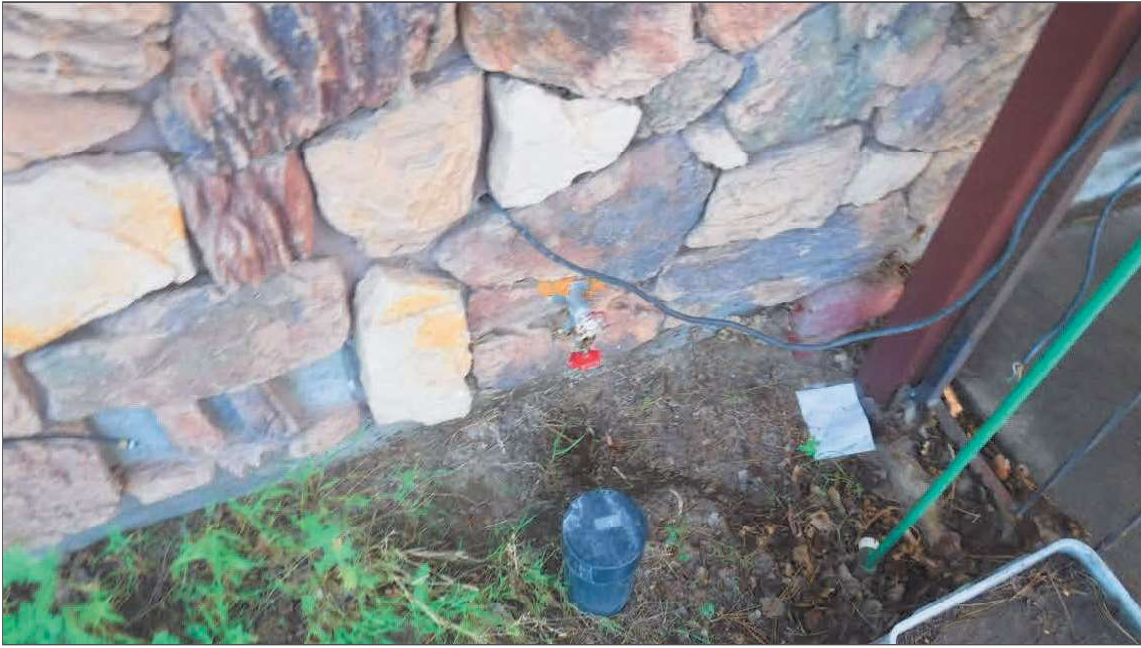
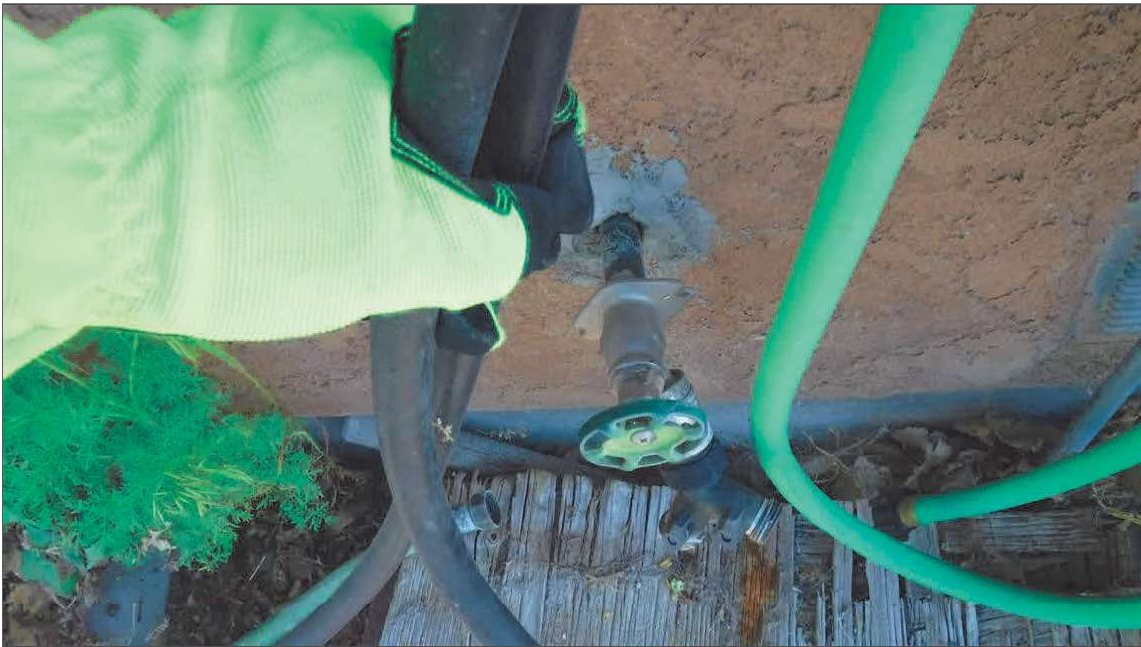
6.1 (1) The water supply, distribution and fixtures were inspected. Most water distribution pipes were not visible due to wall, floor and ceiling coverings. Hose bibs on the exterior are not attached to the wall using the mounting flange.

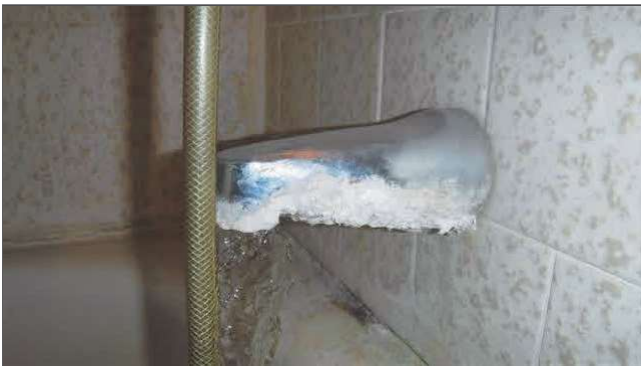
6.1 (2) This faucet looks like it has leaked from underneath in the past. Hard water stains present.

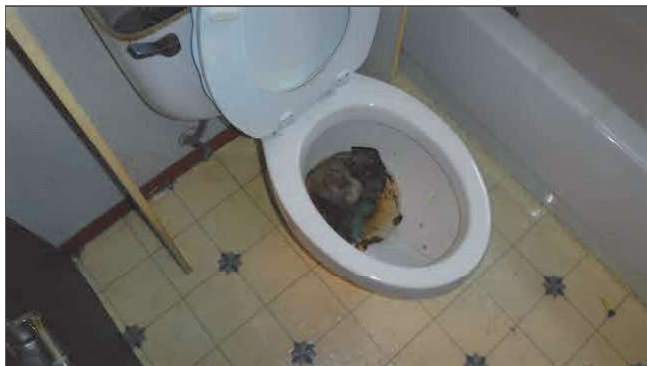
6.1 (3) This toilet looks to have some issues so I did not flush it. The toilet in the guest bathroom leaks from what looks like under the tank.

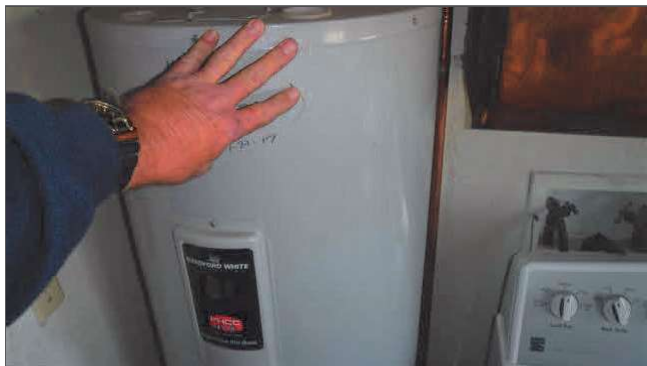
6.2 (2) There are no earthquake straps on the water heater. Although we do not inspect to code, the Uniform Plumbing Code (UPC), section 510.5 says "In seismic zones 3 and 4, water heaters shall be anchored or strapped to resist horizontal displacement due to earthquake motion. Strapping shall be at points within the upper one-third (1/3) and lower one-third (1/3) of its vertical dimensions. At the lower point, a minimum of four (4) inches (102mm) shall be maintained above the controls with the strapping." The area in which the inspection took place is considered zone 3 or 4.

Earthquake straps have not always been required and since we can't be sure 1) When this water heater was installed, and 2) what codes were adopted by this municipality, we are just recommending them.

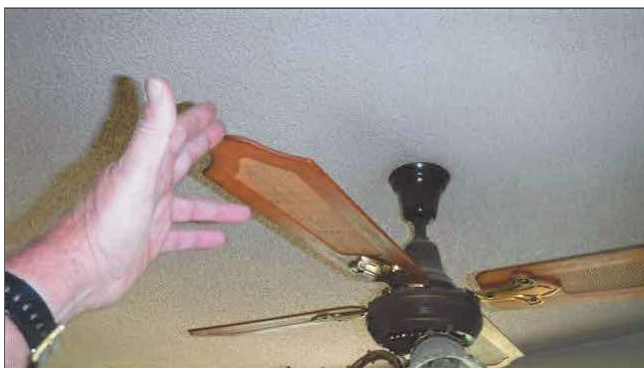
7.1 (1) At the time of the inspection, the Inspector observed few deficiencies in the condition of electrical receptacles in the home. Notable exceptions will be listed in this report. In accordance with the Standards of Practice, the inspector tested a representative number of accessible outlets only.

I couldn't find the switch or right combination of switches to get this fan to come on. The light works fine.

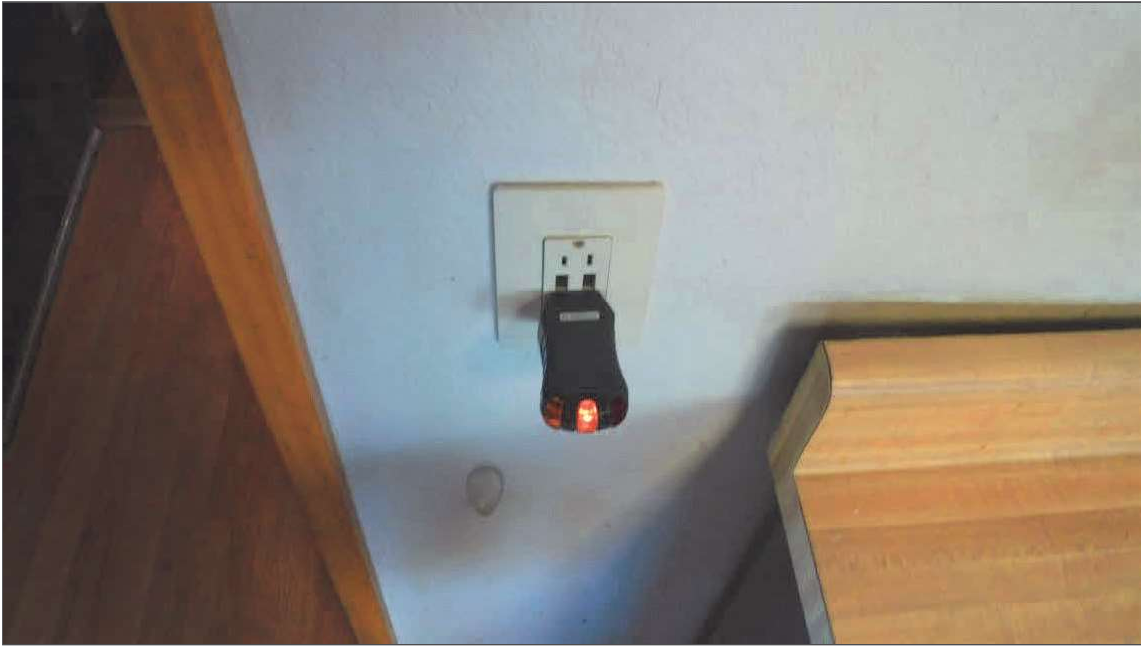
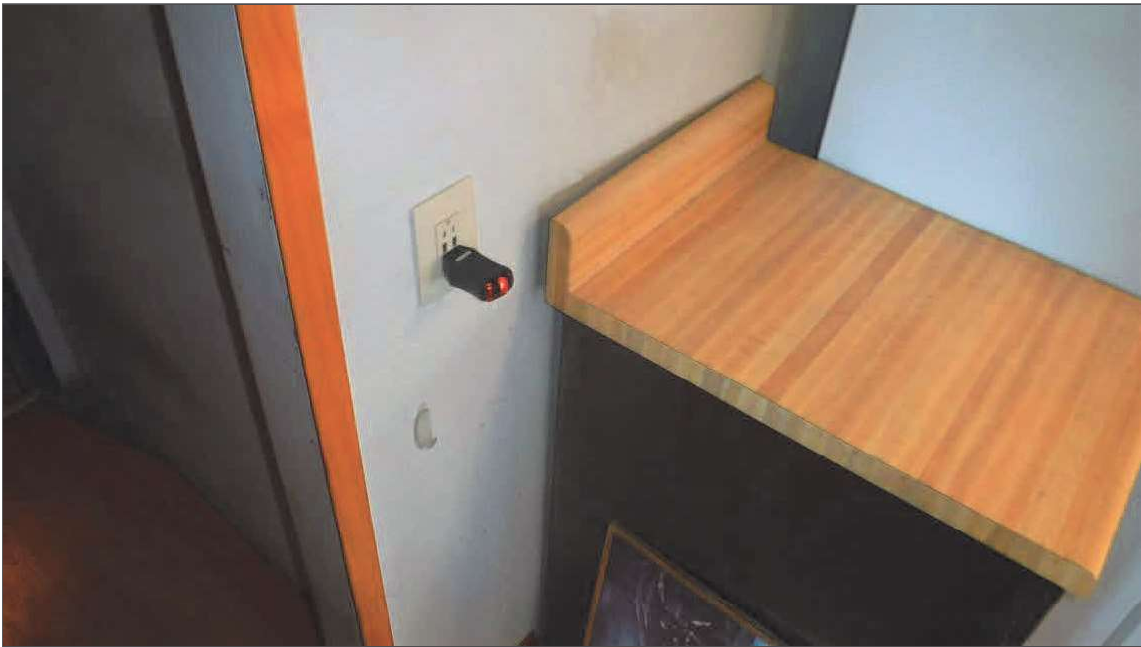
7.1 (2) This receptacle had an Open Ground condition. This condition should be corrected by qualified electrical contractor.

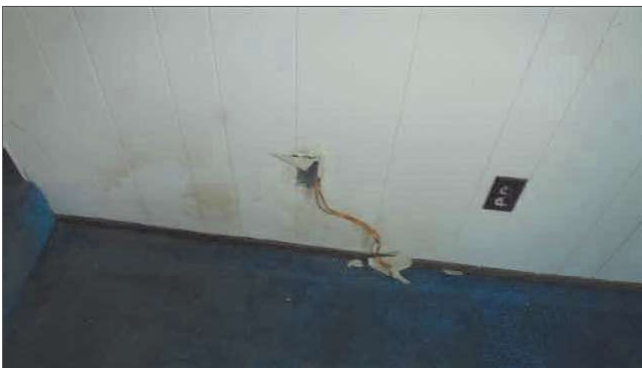
7.1 (3) This junction box is missing a cover.

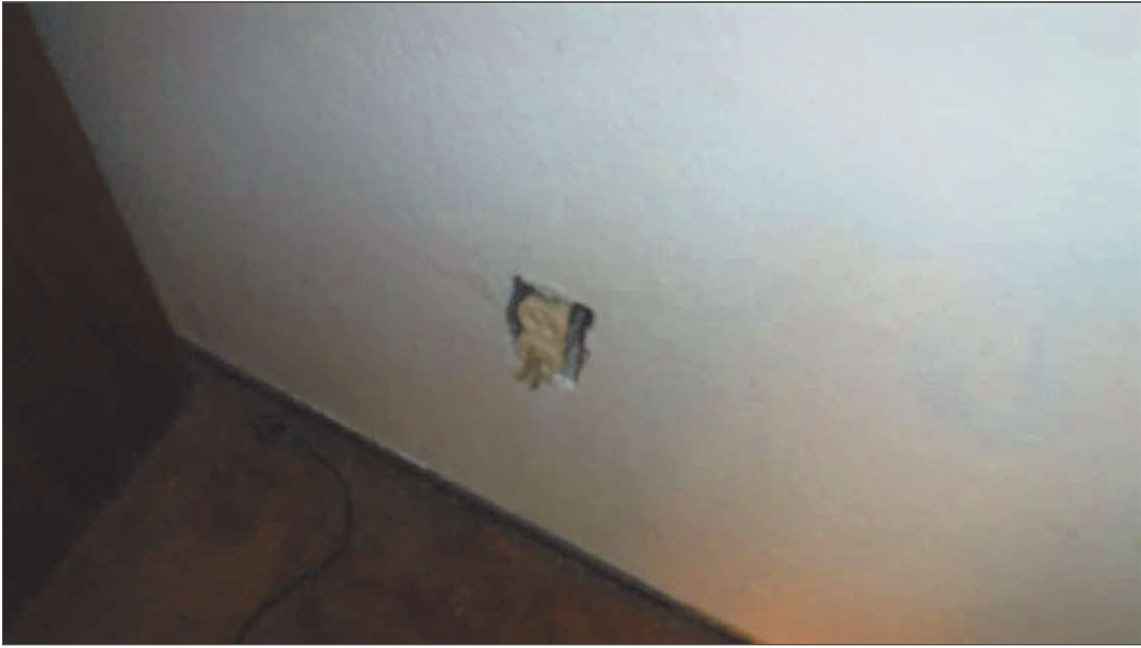
7.1 (4) An electrical receptacle cover plate was missing here. This condition left energized electrical components exposed to touch, a shock/electrocution hazard. The Inspector recommends a cover plate be installed by a qualified electrical contractor.

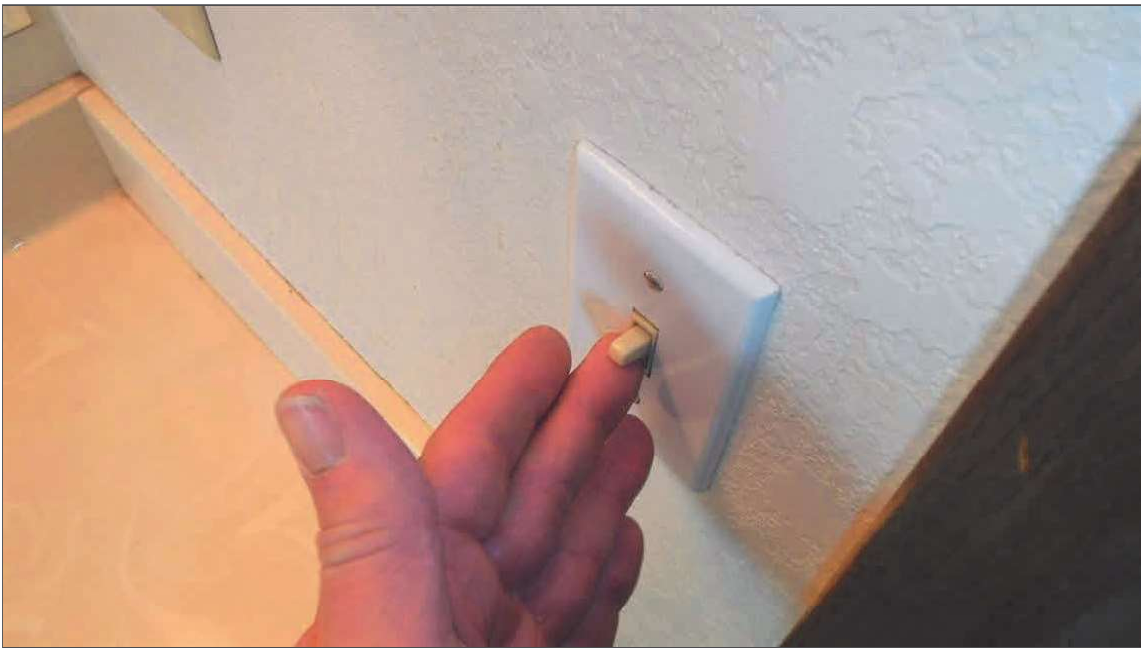
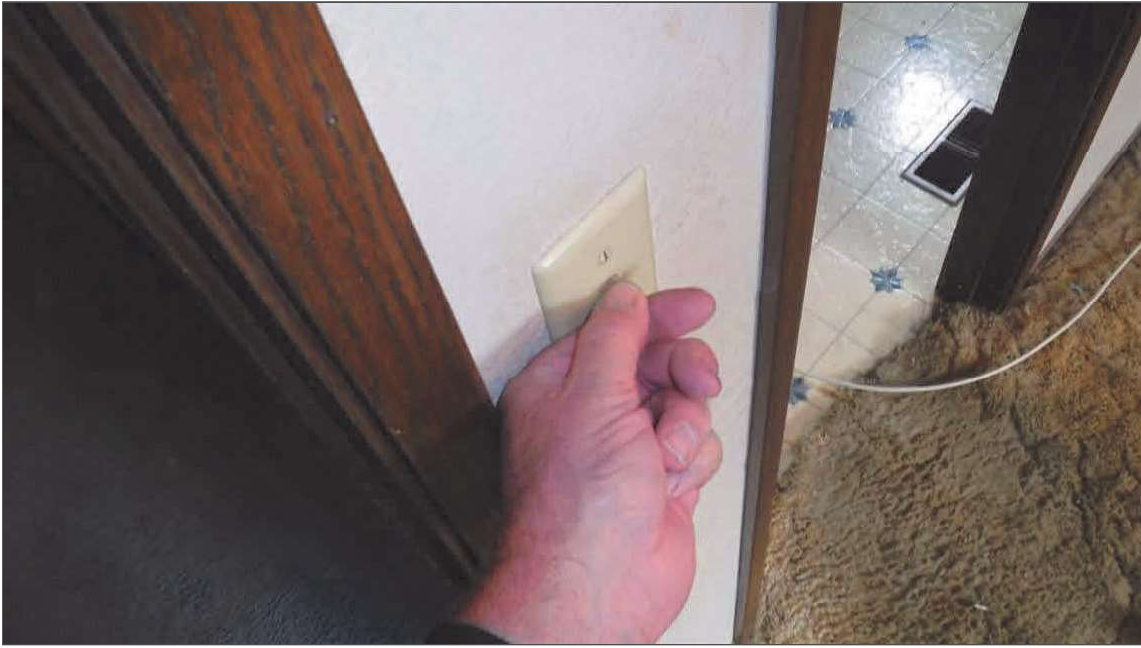
7.1 (5) I few light switches feel like they have a bad spot in them.

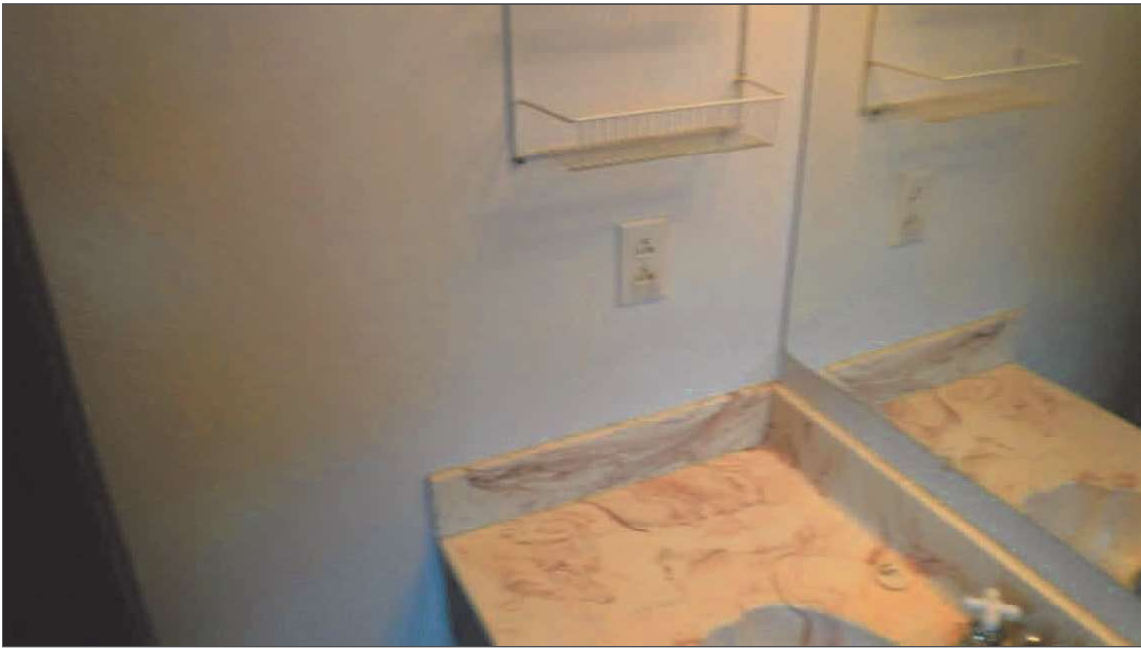
7.1 (6) The receptacle in this bathroom tested fine but you may want to change it. It looks like it's gotten hot.

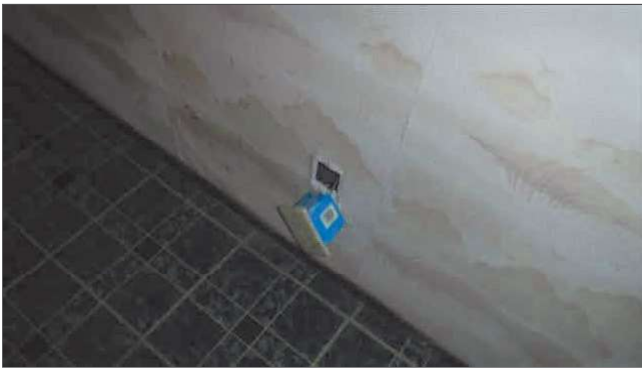
7.1 (7) Loose junction box near the front door.

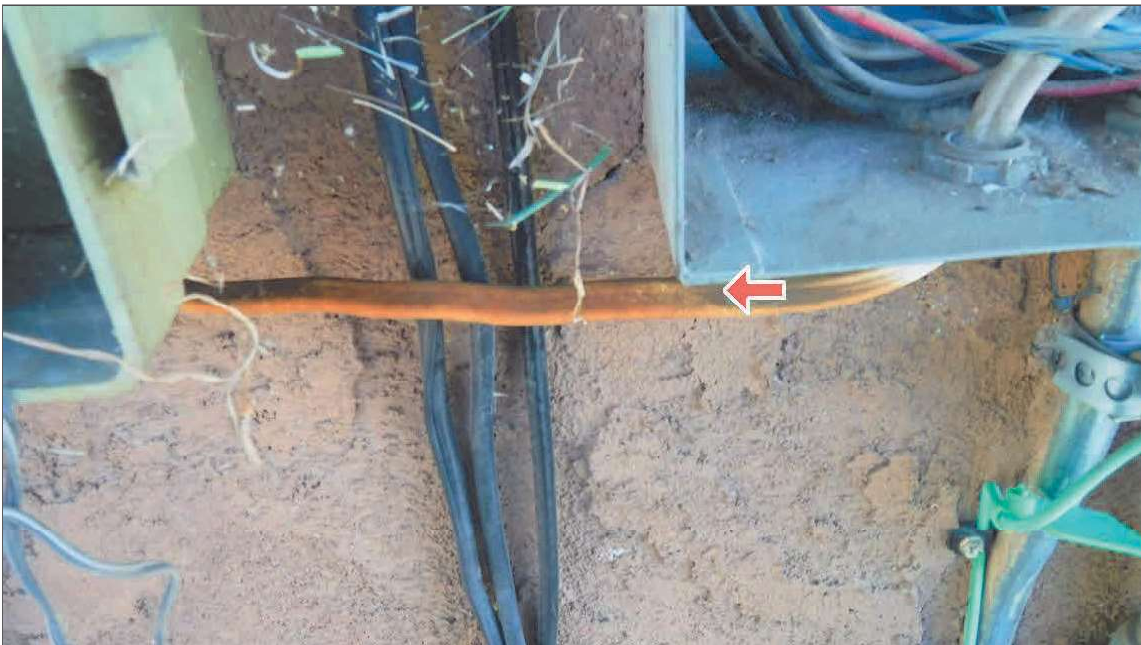
7.2 (1) The home's branch circuits were inspected. Home branch circuit wiring consists of wiring distributing electricity to devices such as switches, receptacles, and appliances. Most conductors are hidden behind floor, wall and ceiling coverings and cannot be evaluated by the inspector. The Inspector does not remove cover plates and inspection of branch wiring is limited to proper response to testing of switches and a representative number of electrical receptacles.

The wire used to provide power to the sprinkler timer out back is not suitable for installation outdoors and the sun is starting to get to it.

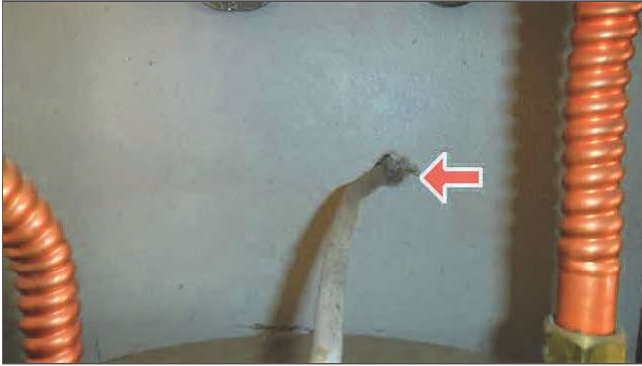
7.2 (2) Wiring for the water heater just passes through the wall here and is not protected from damage.

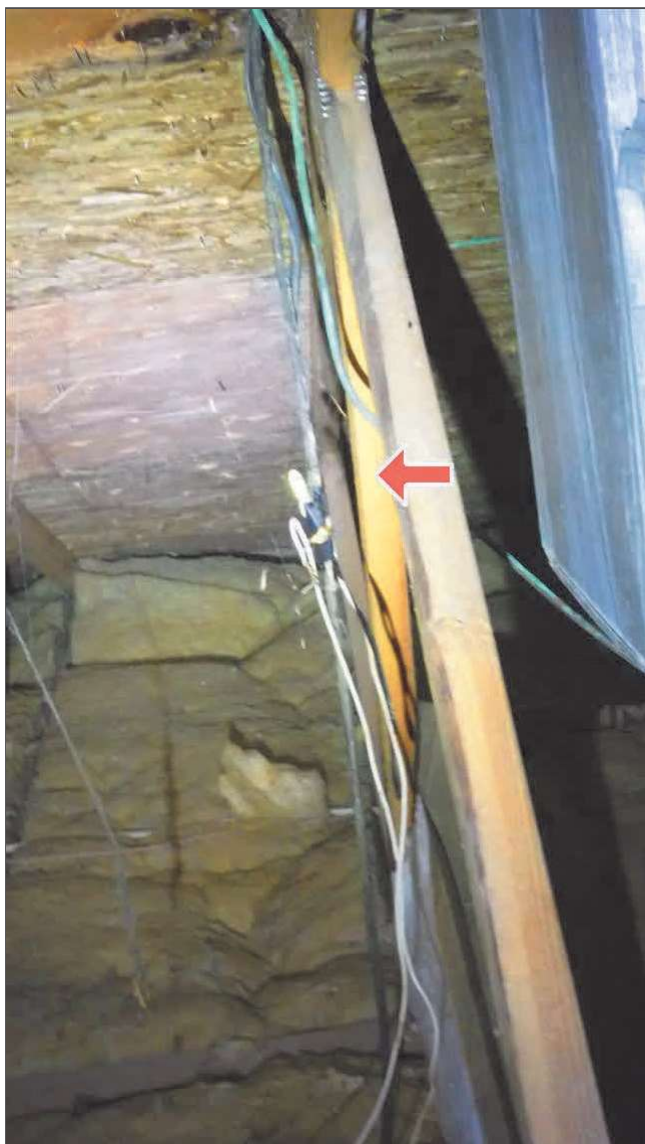
7.2 (3) Exposed wire splices were visible here in the attic next to the cooler duct. These are potentially a shock/electrocution/fire hazard and should be enclosed within an approved junction box with a listed cover by a qualified electrical contractor.

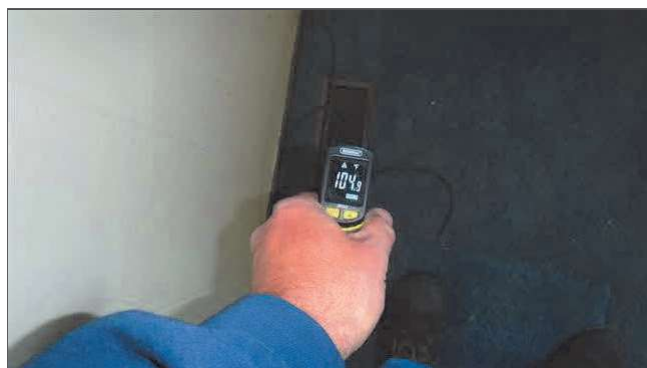
8.0 (1) At the time of the inspection, the Inspector observed few deficiencies in the condition of this furnace. Notable exceptions will be listed in this report.

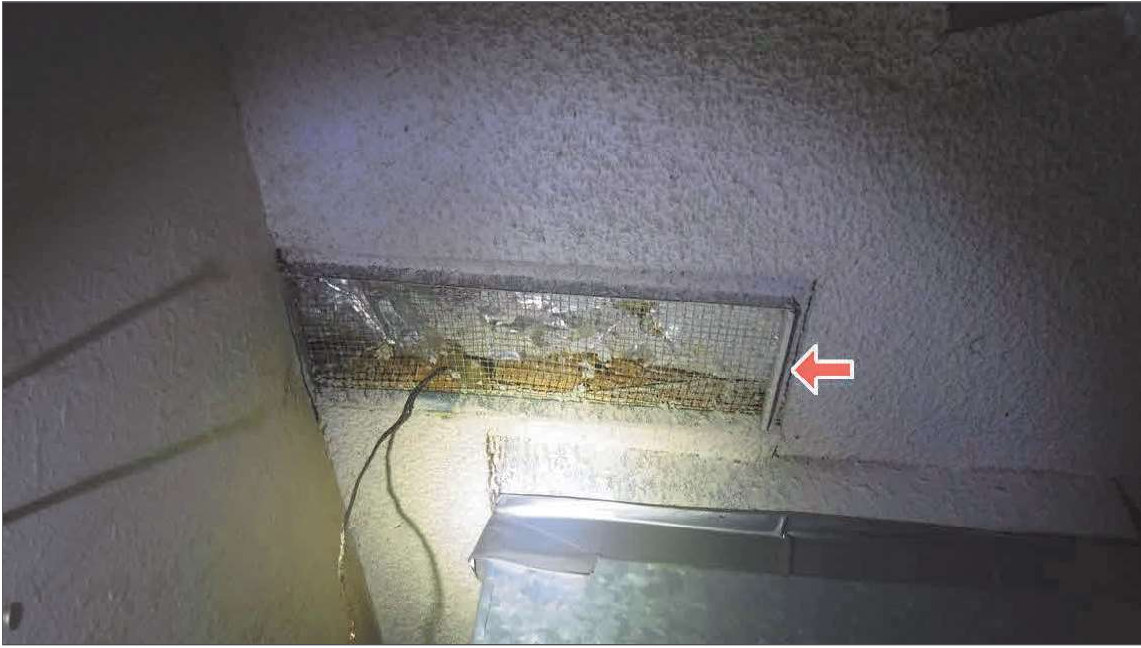
8.0 (2) Insulation should be removed from the combustion air vent in the ceiling of the furnace closet.

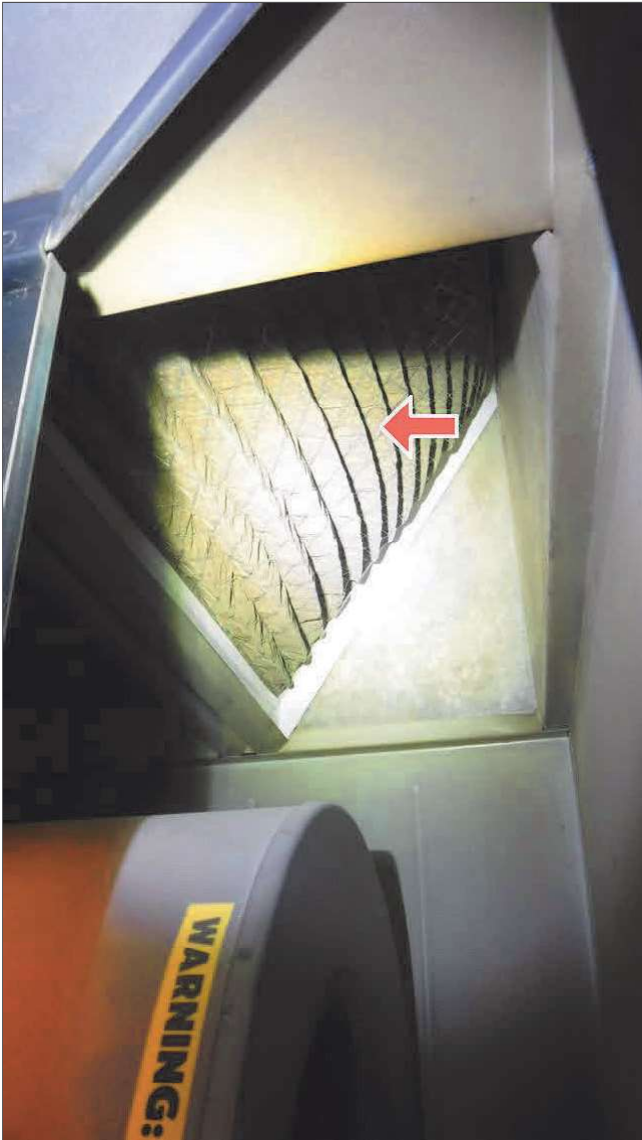
8.4 The air filters for the HVAC system were dirty and should be changed. Filters should be checked every three months and replaced when they reach a condition in which accumulation of particles becomes so thick that particles may be blown loose from the filter and into indoor air. Homes in areas with high indoor levels of airborne pollen or dust may need to have air filters checked and changed more frequently. Failure to change the filter when needed may result in the following problems:

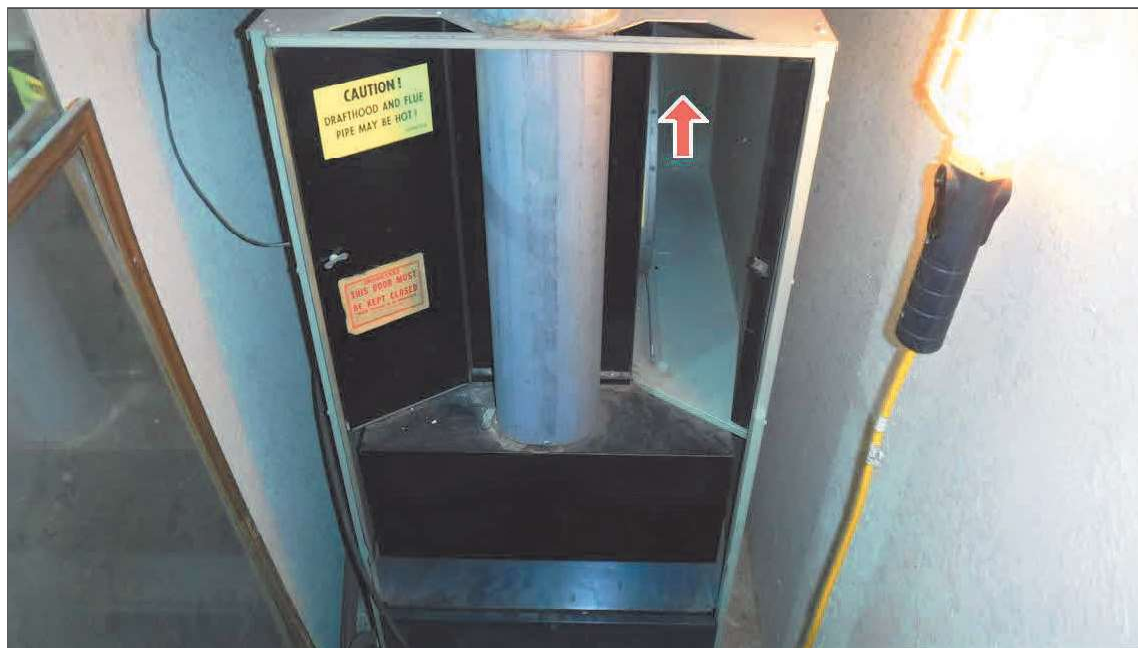
- reduced blower life due to dirt build-up on vanes, which increasing operating costs;
- reduced indoor air quality;
- increased resistance resulting in the filter being sucked into the blower;
- this condition can be a potential fire hazard;
- frost build-up on air-conditioner evaporator coils, resulting in reduced cooling efficiency and possible damage; and reduced air flow through the home.

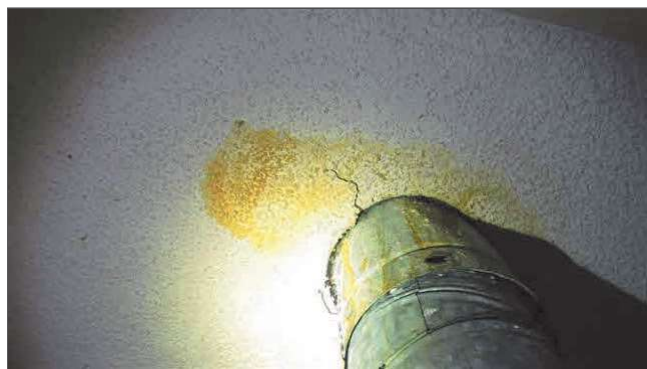
8.5 The combustion exhaust flue for this furnace had improper clearance from combustible materials. This type of vent requires 1-inch minimum clearance. This condition is a potential fire hazard and should be corrected by a qualified contractor.

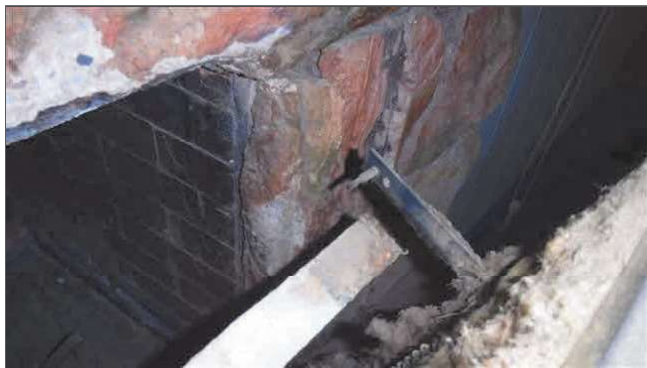
8.6 The home contained a wood-burning fireplace located in the living room. We may note obvious deficiencies but a full inspection of fireplaces lies beyond the scope of the General Home Inspection. For a full inspection to more accurately determine the condition of the fireplace and to ensure that safe conditions exist, the Inspector recommends that you have the fireplace inspected by an inspector certified by the Chimney Safety Institute of America (CSIA). Find a CSIA-certified inspector near you at <http://www.csia.org/search>

The front part of the fireplace pulls away from the wall.

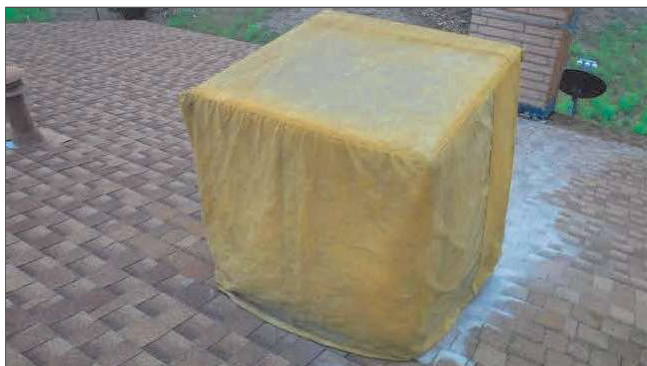
8.8 (1) The home had a single-stage evaporative cooler (also called a "swamp cooler"). In low-humidity areas, evaporating water into the air provides a natural and energy-efficient means of cooling. Evaporative coolers rely on this principal, cooling outdoor air by passing it over water-saturated pads, causing the water to evaporate into it. The 15F- 40F-cooler air is then directed into the home, and pushes warmer air out through the windows. When operating an evaporative cooler, windows are opened part way to allow warm indoor air to escape as it is replaced by cooled air. Unlike central air conditioning systems that recirculate the same air, evaporative coolers provide a steady stream of fresh air into the house. Evaporative coolers cost about half as much to install as central air conditioners and use about one-quarter as much energy. However, they require more frequent maintenance than conventional air-conditioners and they're more suitable for areas with low humidity. Evaporative coolers require maintenance. Here are some of the items which should be checked at the beginning of each cooling season:

The evaporative cooler should be winterized. Evaporative coolers must be commissioned after being winterized, meaning a water source must be connected and maintenance must be performed. This is typically done by a plumbing or HVAC contractor. The Inspector recommends evaluation by a qualified HVAC contractor.

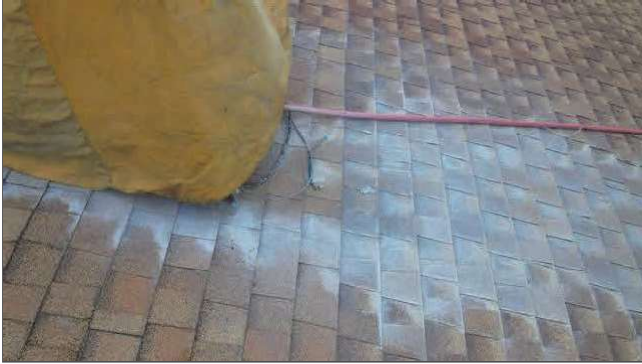
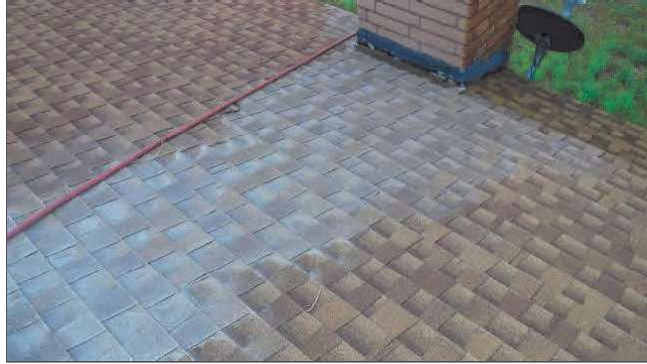
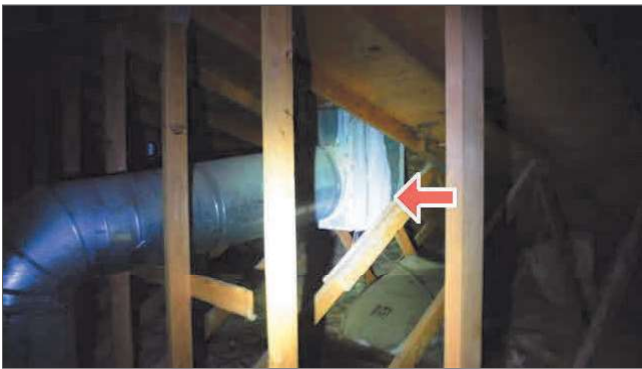
8.8 (2) The cooler has leaked quite a bit in the past. It's stained the shingles, and the wood under the cooler in the attic area. The water has also gone down and damaged the ceiling in the living room.

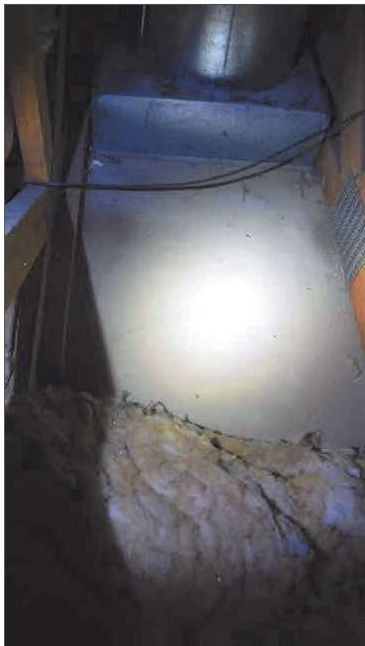
9.0 The insulation in the attic was inspected and found to be ok. Any discrepancies will be noted in this report. The Inspector disclaims confirmation of adequate attic ventilation year-round performance, but will comment on the apparent adequacy of the system as experienced by the inspector on the day of the inspection. Attic ventilation is not an exact science and a standard ventilation approach that works well in one type of climate zone may not work well in another. The performance of a standard attic ventilation design system can vary even with different homesite locations and conditions or weather conditions within a single climate zone. The typical approach is to thermally isolate the attic space from the living space by installing some type of thermal insulation on the attic floor. Heat that is radiated into the attic from sunlight shining on the roof is then removed using devices that allow natural air movement to carry hot air to the home exterior. This reduces summer cooling

There's a small area in the attic that is missing insulation.

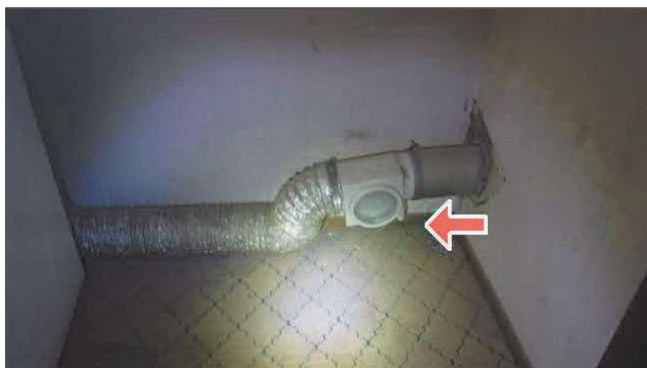
9.4 A dryer vent connection was installed in the laundry room. A visual examination will not detect the presence of lint accumulated inside the vent, which is a potential fire hazard. The Inspector recommends that you have the dryer vent cleaned at the time of purchase and annually in the future to help ensure that safe conditions exist. Lint accumulation can occur even in approved, properly installed vents. All work should be performed by a qualified contractor.

I'm not sure what this assembly is for on the dryer vent but this should probably be removed.

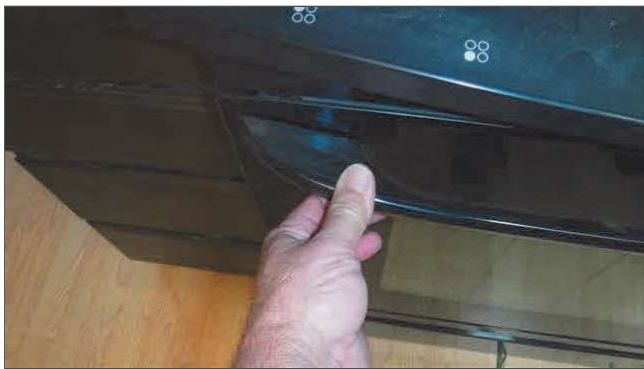
The handle is loose on the oven but it works fine.

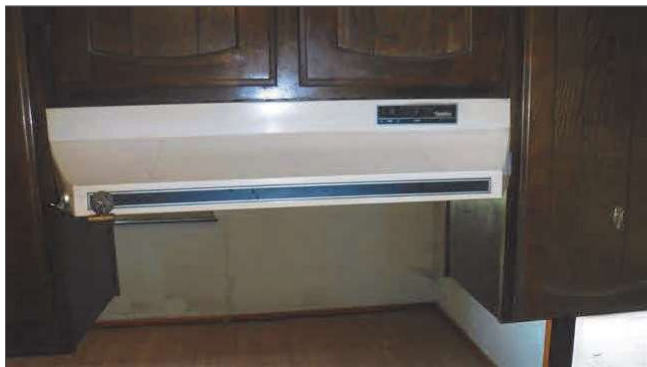
10.1 At the time of the inspection, the Inspector observed no deficiencies in the condition and operation of the range hood exhaust fan but the bulb is missing for the light.

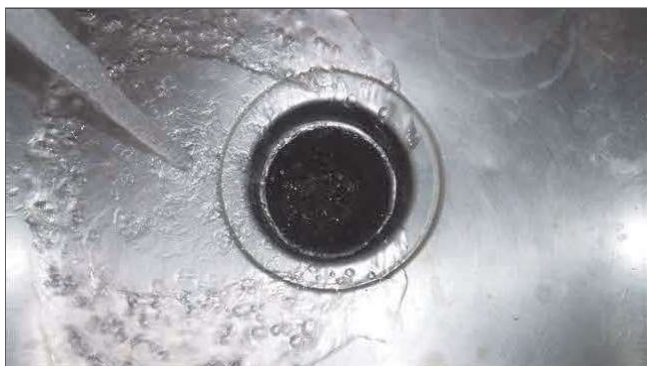
10.2 The garbage disposal was excessively noisy. The Inspector recommends service by a qualified plumbing contractor. And the rubber collar that helps keep things from falling down there is missing.

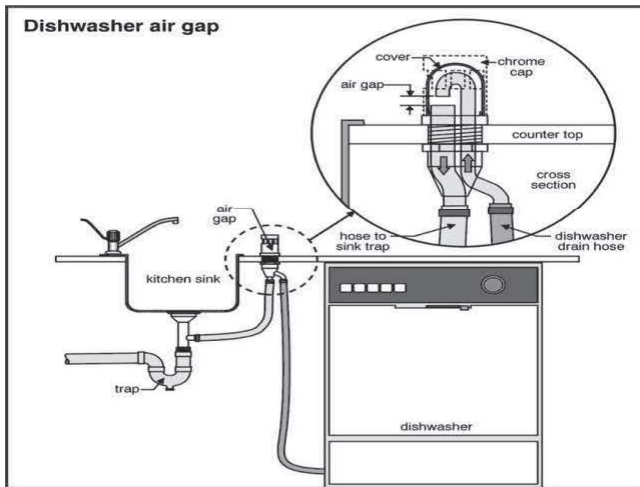
10.3 (2) The dishwasher did not appear to have an anti-siphon device installed in the drain line. Sometimes the anti-siphon device is located inside of the dishwasher so the presence of the external, countertop mounted one is not required. We can't know for sure if the currently installed dishwasher has this device internally.
