Inspection Report

123 Fernley Ct
Fernley, NV 89408

Home Inspection Associates, LLC

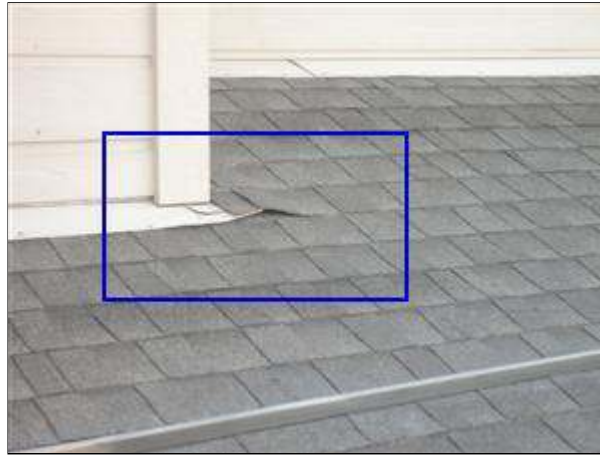
1.0 Picture 1

The roof covering is being lifted up by the flashing at the front of home. This does not appear adequate. It should be properly repaired or replaced. I recommend repair as desired.

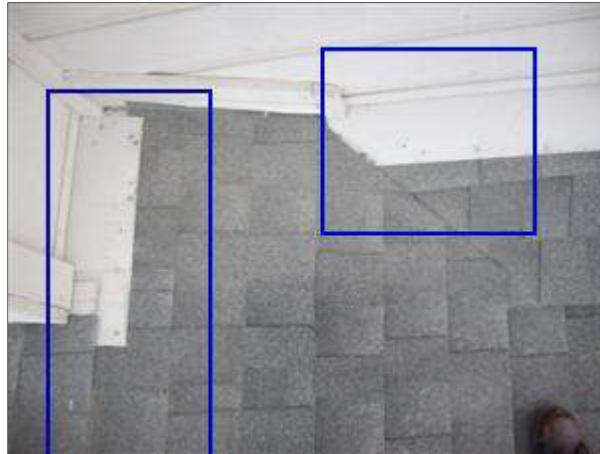
1.1 Picture 1

The flashing at the front edge of the home's roof has nail holes in it from a previous installation. Recommend seal holes.

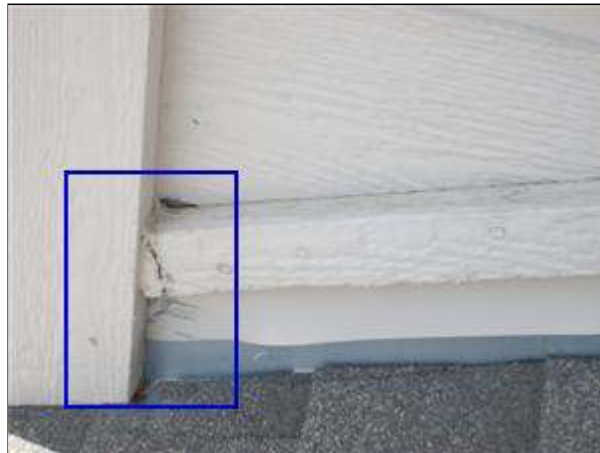
1.3 Picture 1

There is some evidence of water damage on the trim piece on the front of the home where the wall facing East meets the roofline. Repair as needed.

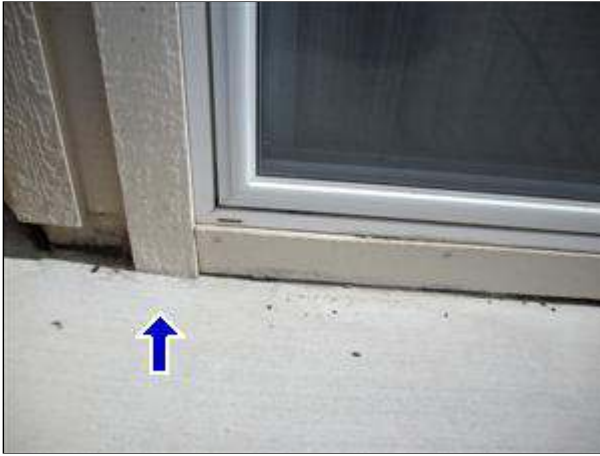
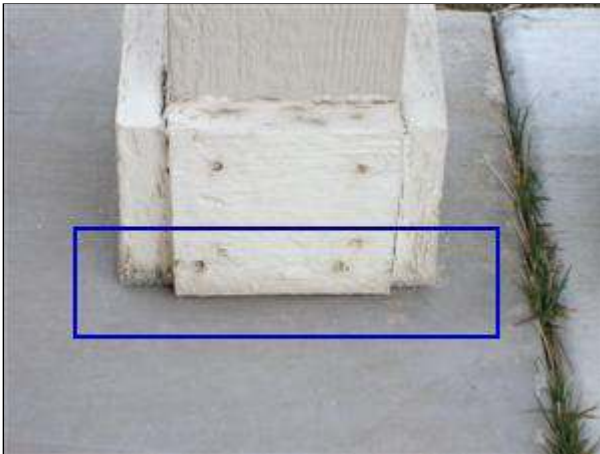
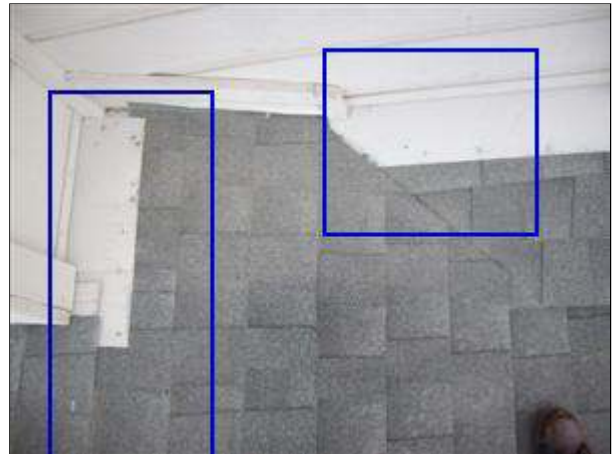
The wood trim at the covered porch and back patio is in direct contact with concrete and is allowing water to be absorbed along the bottom edge. Further deterioration can occur if not corrected. A qualified person should repair or replace as needed.

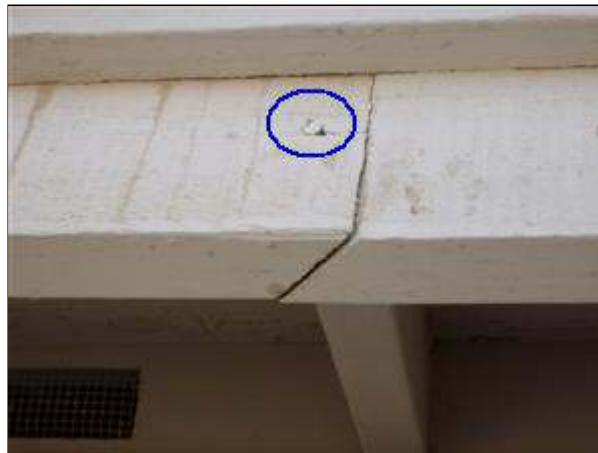
2.1 Picture 1

A gap between the two pieces of joined fascia exists which was caused by the boards twisting/warping. Only one nail is present. Repair to prevent further warping.

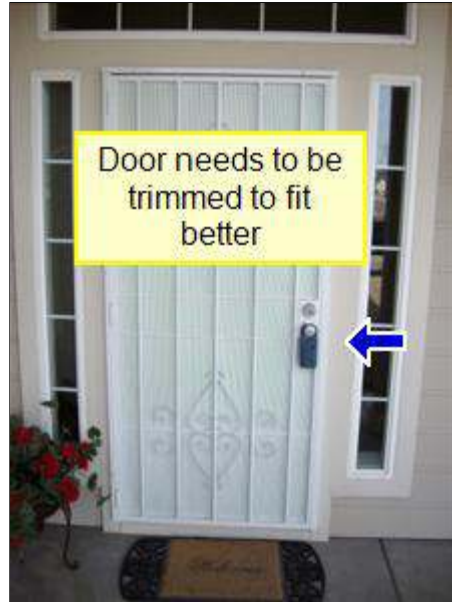
2.2 Picture 1

The main entry door rubs at jamb when closing. This is a maintenance issue and is for your information. I recommend repair as desired.

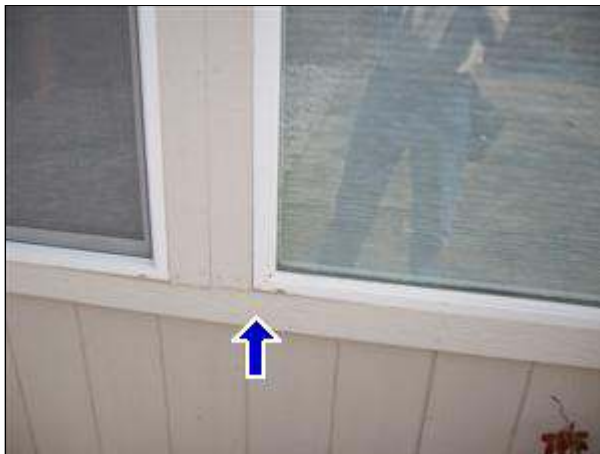
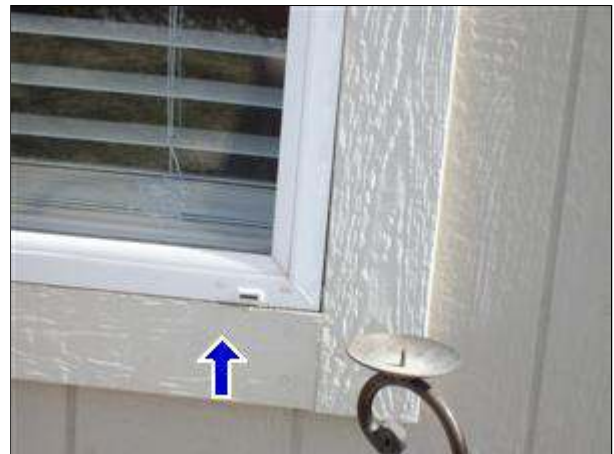
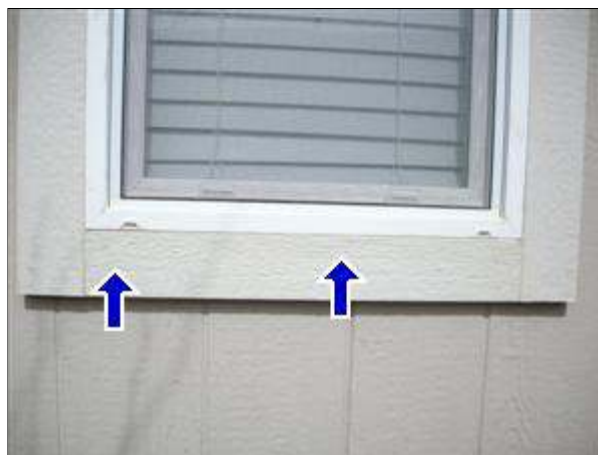
The window frames on the outside and inside in a few places have deteriorated sealant and could lead to water intrusion. Further deterioration may occur if not repaired. I recommend repair as desired.

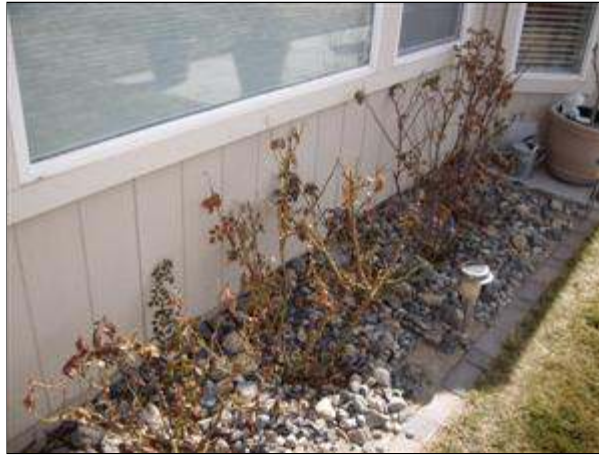
2.5 Picture 1

(1) The rose bushes are in contact with the wall under the back window. They should be trimmed to reduce the chances of insects finding their way into the home. This is for your information

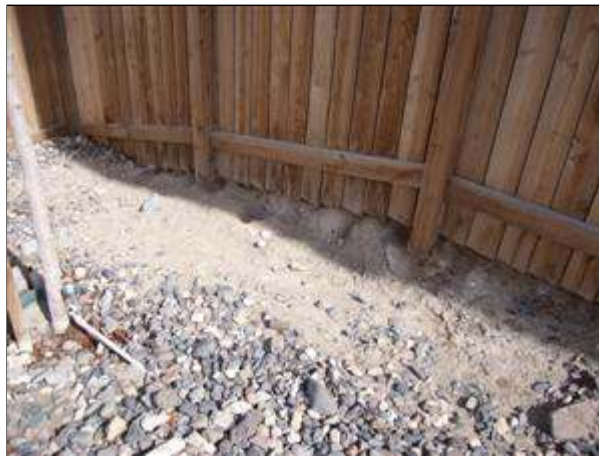
2.5 Picture 2

(2) There is a drainage slope at the rear of the home. This area appears to drain water away from home but needs some fill and rocks to prevent further erosion. This is for your information.

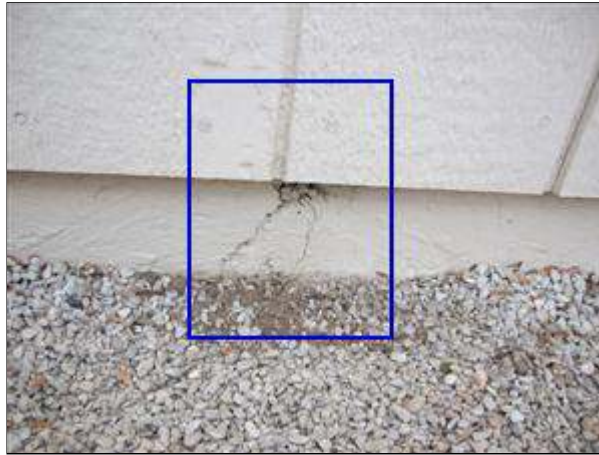
3.0 Picture 1

The foundation wall at the left side (facing front) is deteriorated. No repairs are needed or foreseen at this time. These typical cracks are likely of no concern.

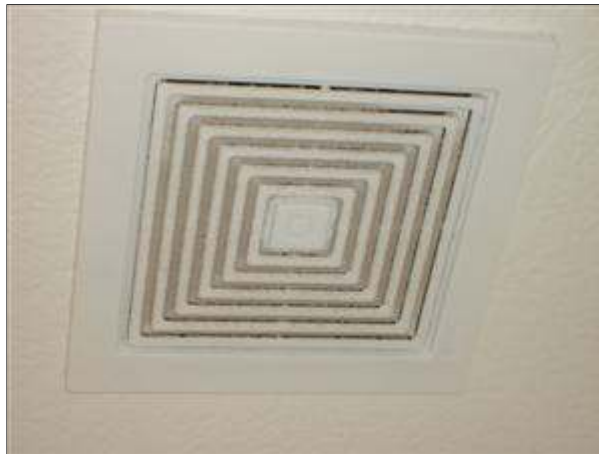
4.3 Picture 2

(2) The exhaust fan cover in the master bath toilet area is dirty and needs cleaning.

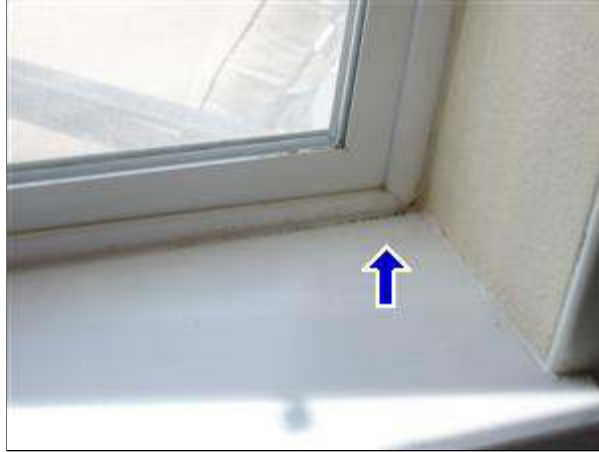
8.6 Picture 1

One window has deteriorated sealant in the Guest Bedroom. This is a maintenance issue and is for your information. I recommend prep prime and paint as needed.

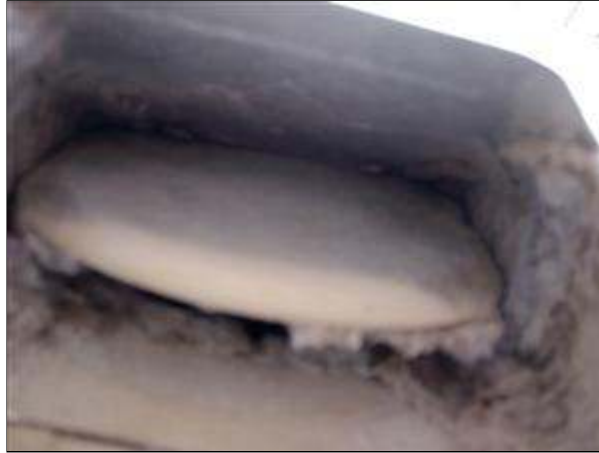
9.2 Picture 2

(2) Dryer vent on the outside of the home has build up of lint. This is a safety issue as a potential for fire exists if the dryer cannot vent properly.

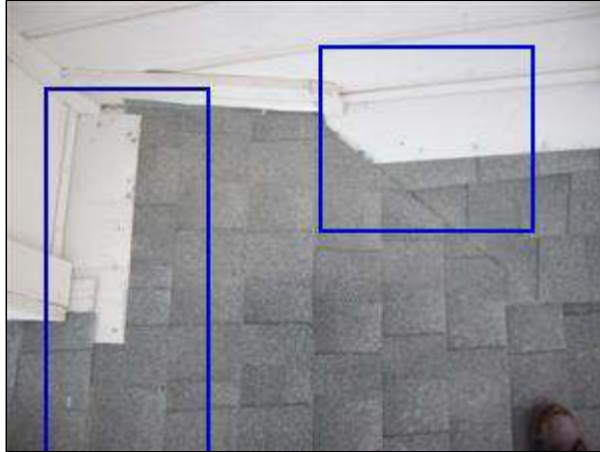
1.1 Picture 1

1.1 The flashing at the front edge of the home's roof has nail holes in it from a previous installation. Recommend seal holes.

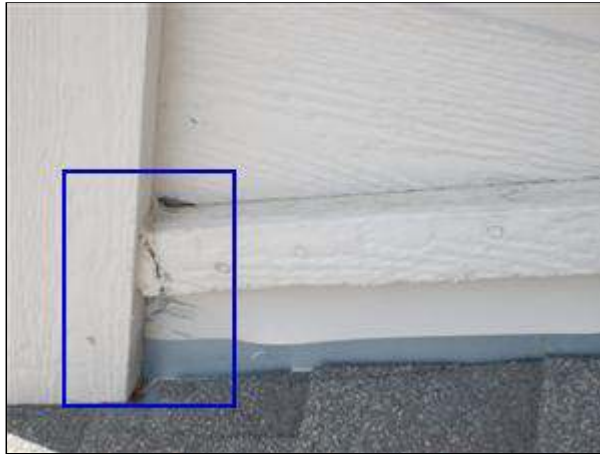
1.3 Picture 1

1.3 There is some evidence of water damage on the trim piece on the front of the home where the wall facing East meets the roofline. Repair as needed.

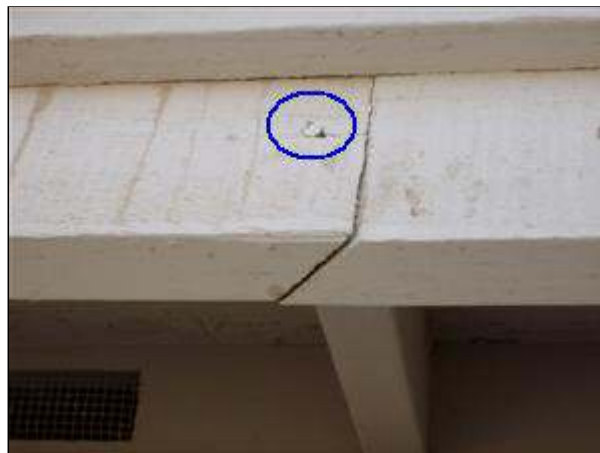
2.1 Picture 1

🏠 2.1 A gap between the two pieces of joined fascia exists which was caused by the boards twisting/warping. Only one nail is present. Repair to prevent further warping.

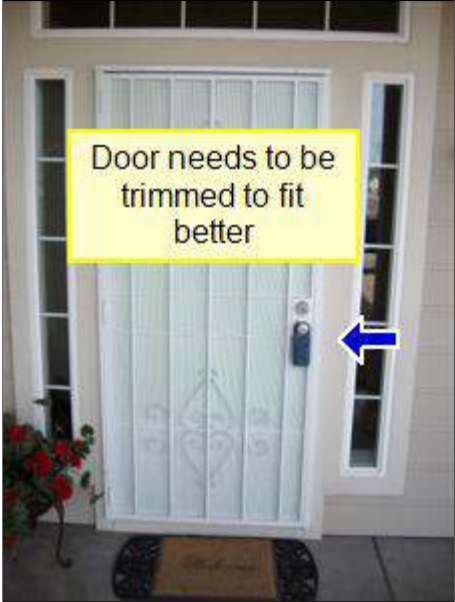
2.2 Picture 1

🏠 2.2 The main entry door rubs at jamb when closing. This is a maintenance issue and is for your information. I recommend repair as desired.

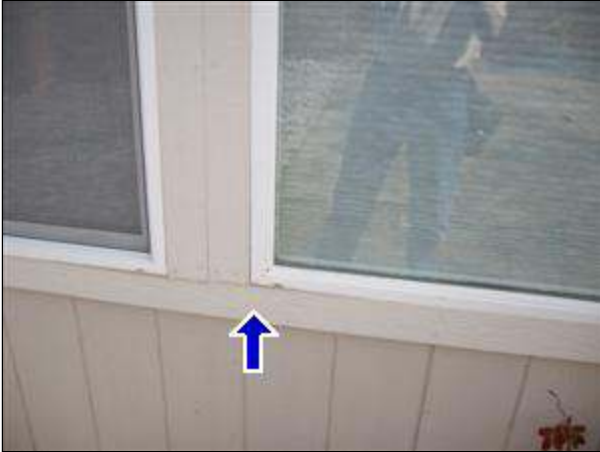
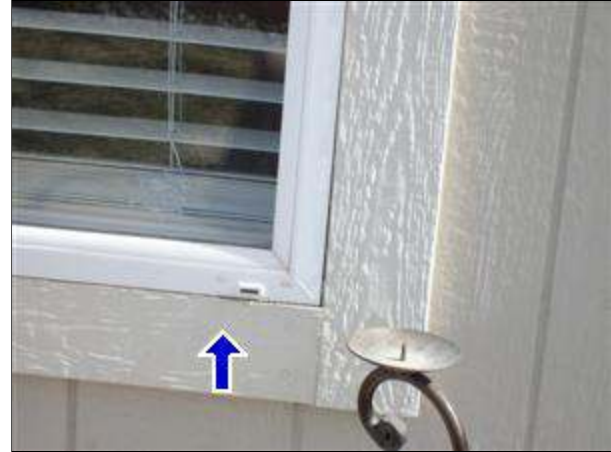
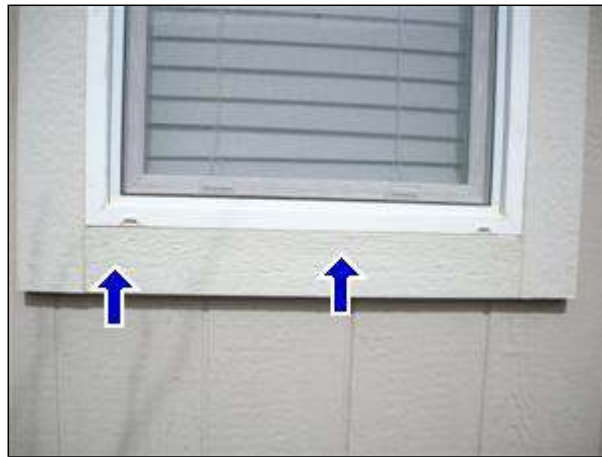
**2.3** The window frames on the outside and inside in a few places have deteriorated sealant and could lead to water intrusion. Further deterioration may occur if not repaired. I recommend repair as desired.

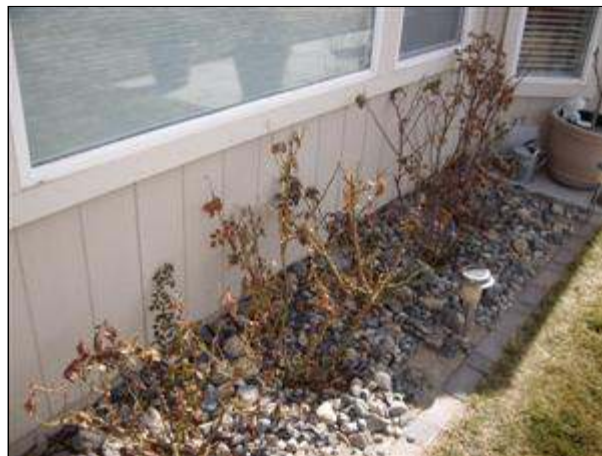
2.5 Picture 1

**2.5 (1)** The rose bushes are in contact with the wall under the back window. They should be trimmed to reduce the chances of insects finding their way into the home. This is for your information

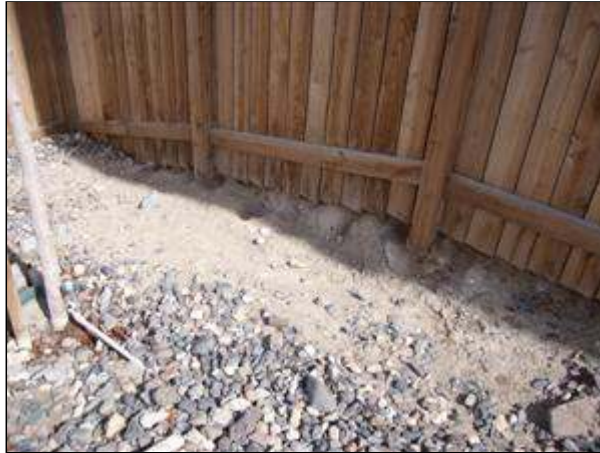
2.5 Picture 2

(2) There is a drainage slope at the rear of the home. This area appears to drain water away from home but needs some fill and rocks to prevent further erosion. This if for your information.

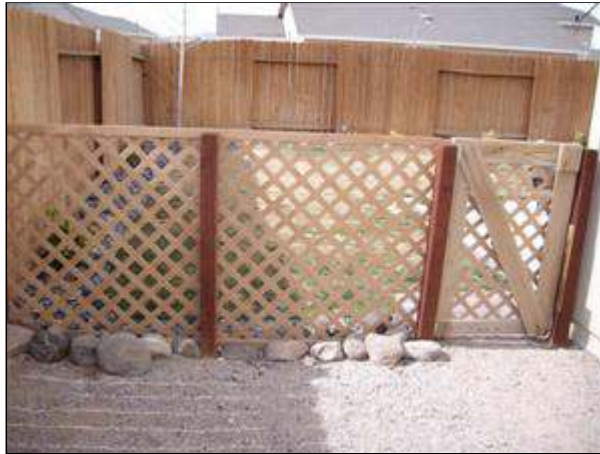
2.6 Picture 1

2.6 This fence is temporary in nature. This if for your information.

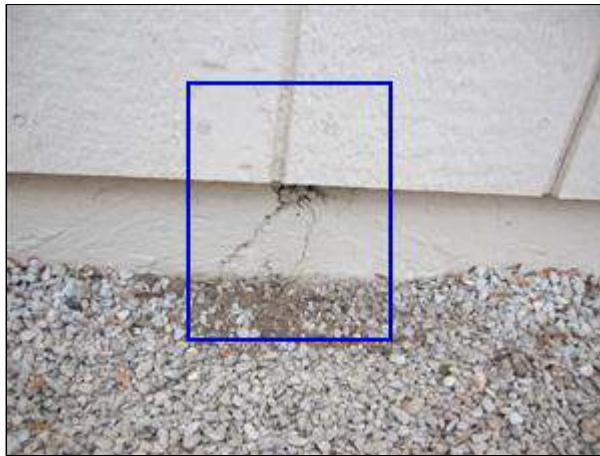
3.0 Picture 1

**3.0** The foundation wall at the left side (facing front) is deteriorated. No repairs are needed or foreseen at this time. These typical cracks are likely of no concern.

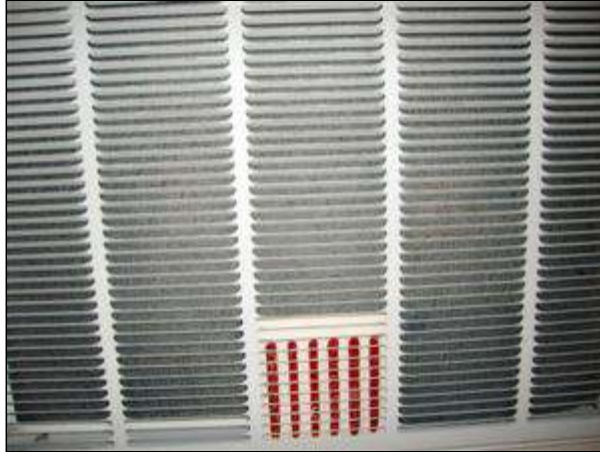
4.3 Picture 1

4.3 (1) The disposable filter for the heating and air conditioner in the upstairs hallway is a bit dirty. The filter likely needs to be replaced soon. I recommend repair or replace as needed.

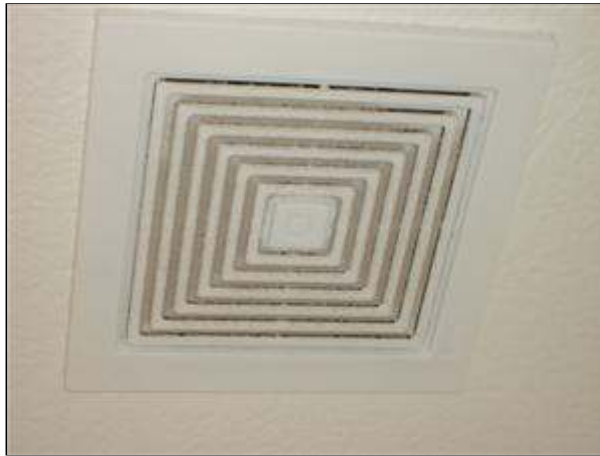
4.3 Picture 2

(2) The exhaust fan cover in the master bath toilet area is dirty and needs cleaning.

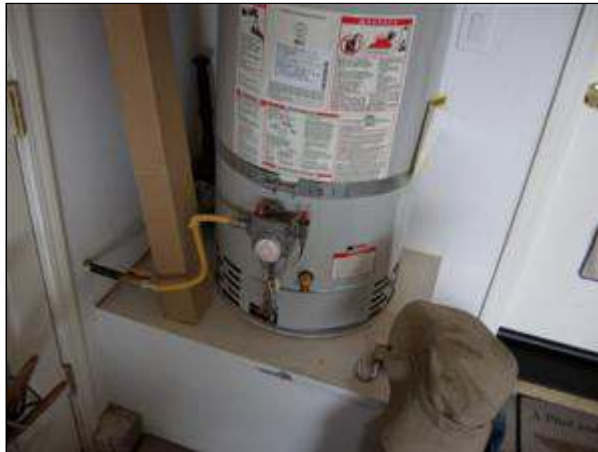
7.0 Picture 1

7.0 The installed gas water heater has items around its vent openings. This may restrict air flow. This is for your information.

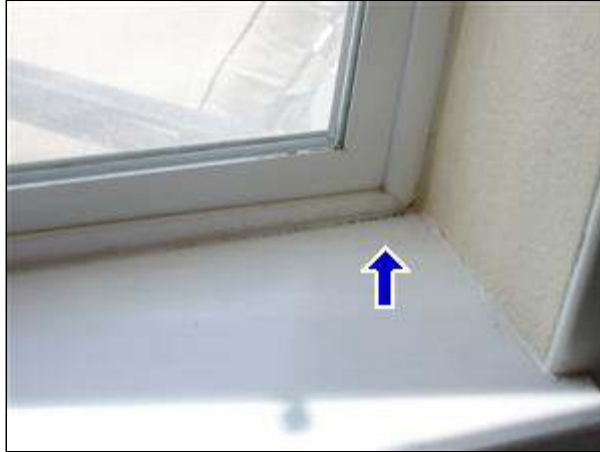
8.6 Picture 1

8.6 One window has deteriorated sealant in the Guest Bedroom. This is a maintenance issue and is for your information. I recommend prep prime and paint as needed.

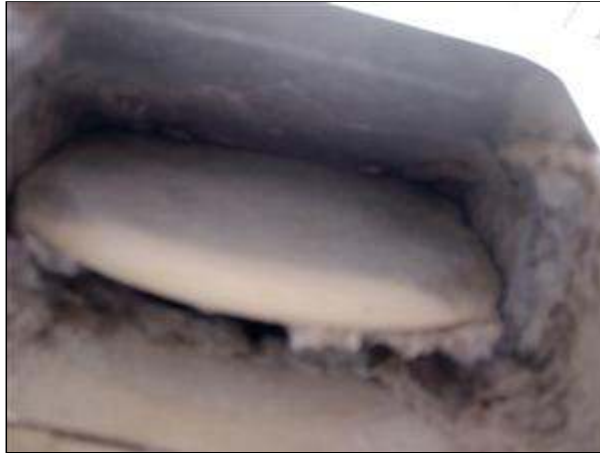
9.2 Picture 2

(2) Dryer vent on the outside of the home has build up of lint. This is a safety issue as a potential for fire exists if the dryer cannot vent properly.
